Fluvial Geomorphic Assessment of the South River Watershed, MA

Franklin Regional Council of Governments
Greenfield, MA

John Field
Field Geology Services
Farmington, ME

February 2013

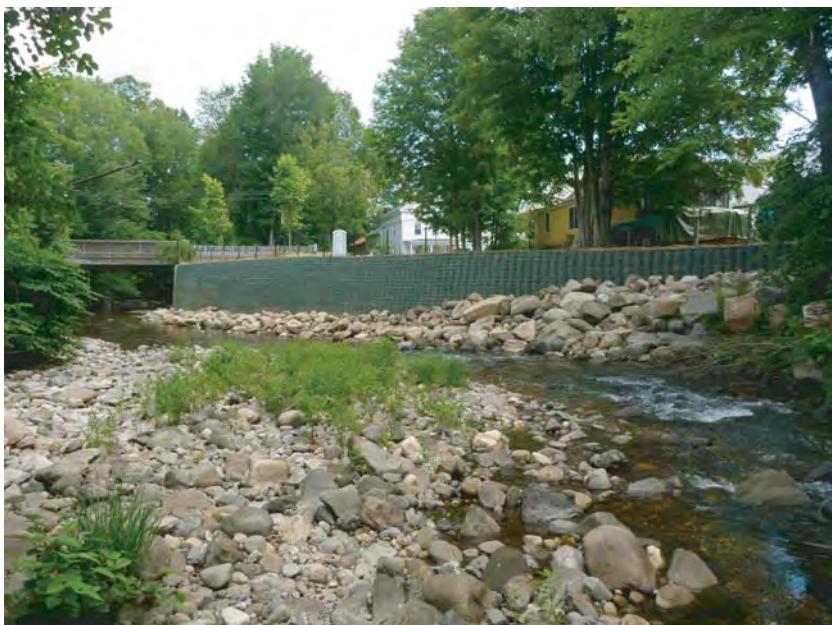
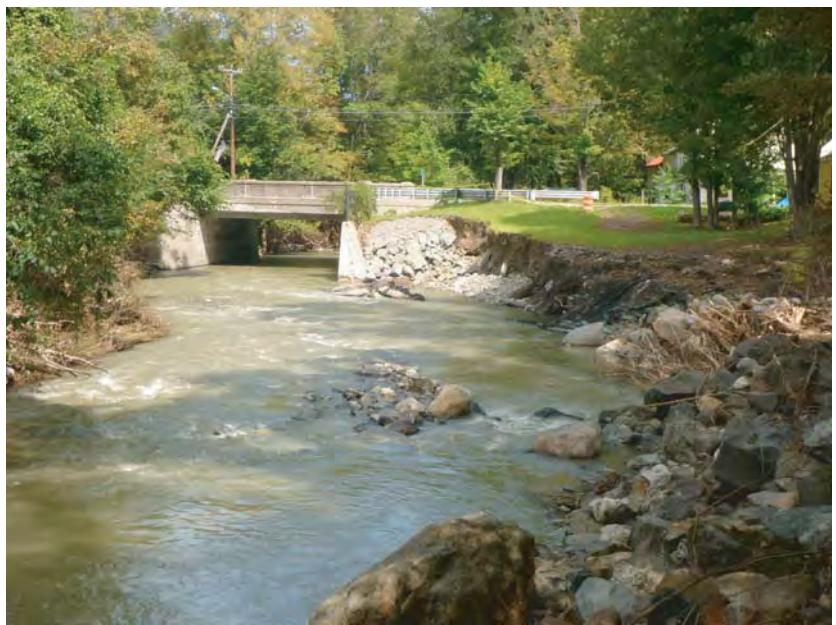
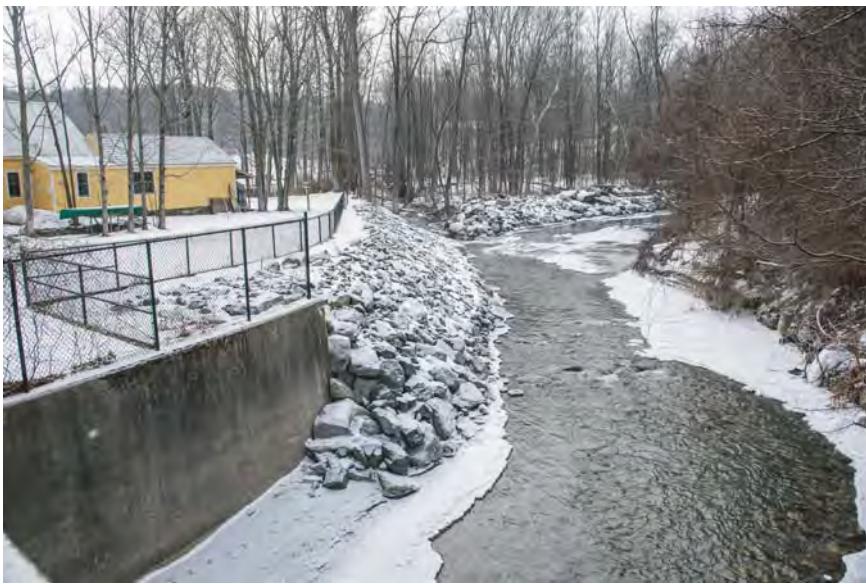
Figure 4. Impact of Tropical Storm Irene flooding and subsequent river management as revealed just upstream of Route 116 Bridge where a) bank repairs completed in early August 2011 were b) washed away by flooding on August 28, 2011 with c) post-flooding bank repairs further constricting channel (photo "c" courtesy of M.Turre).

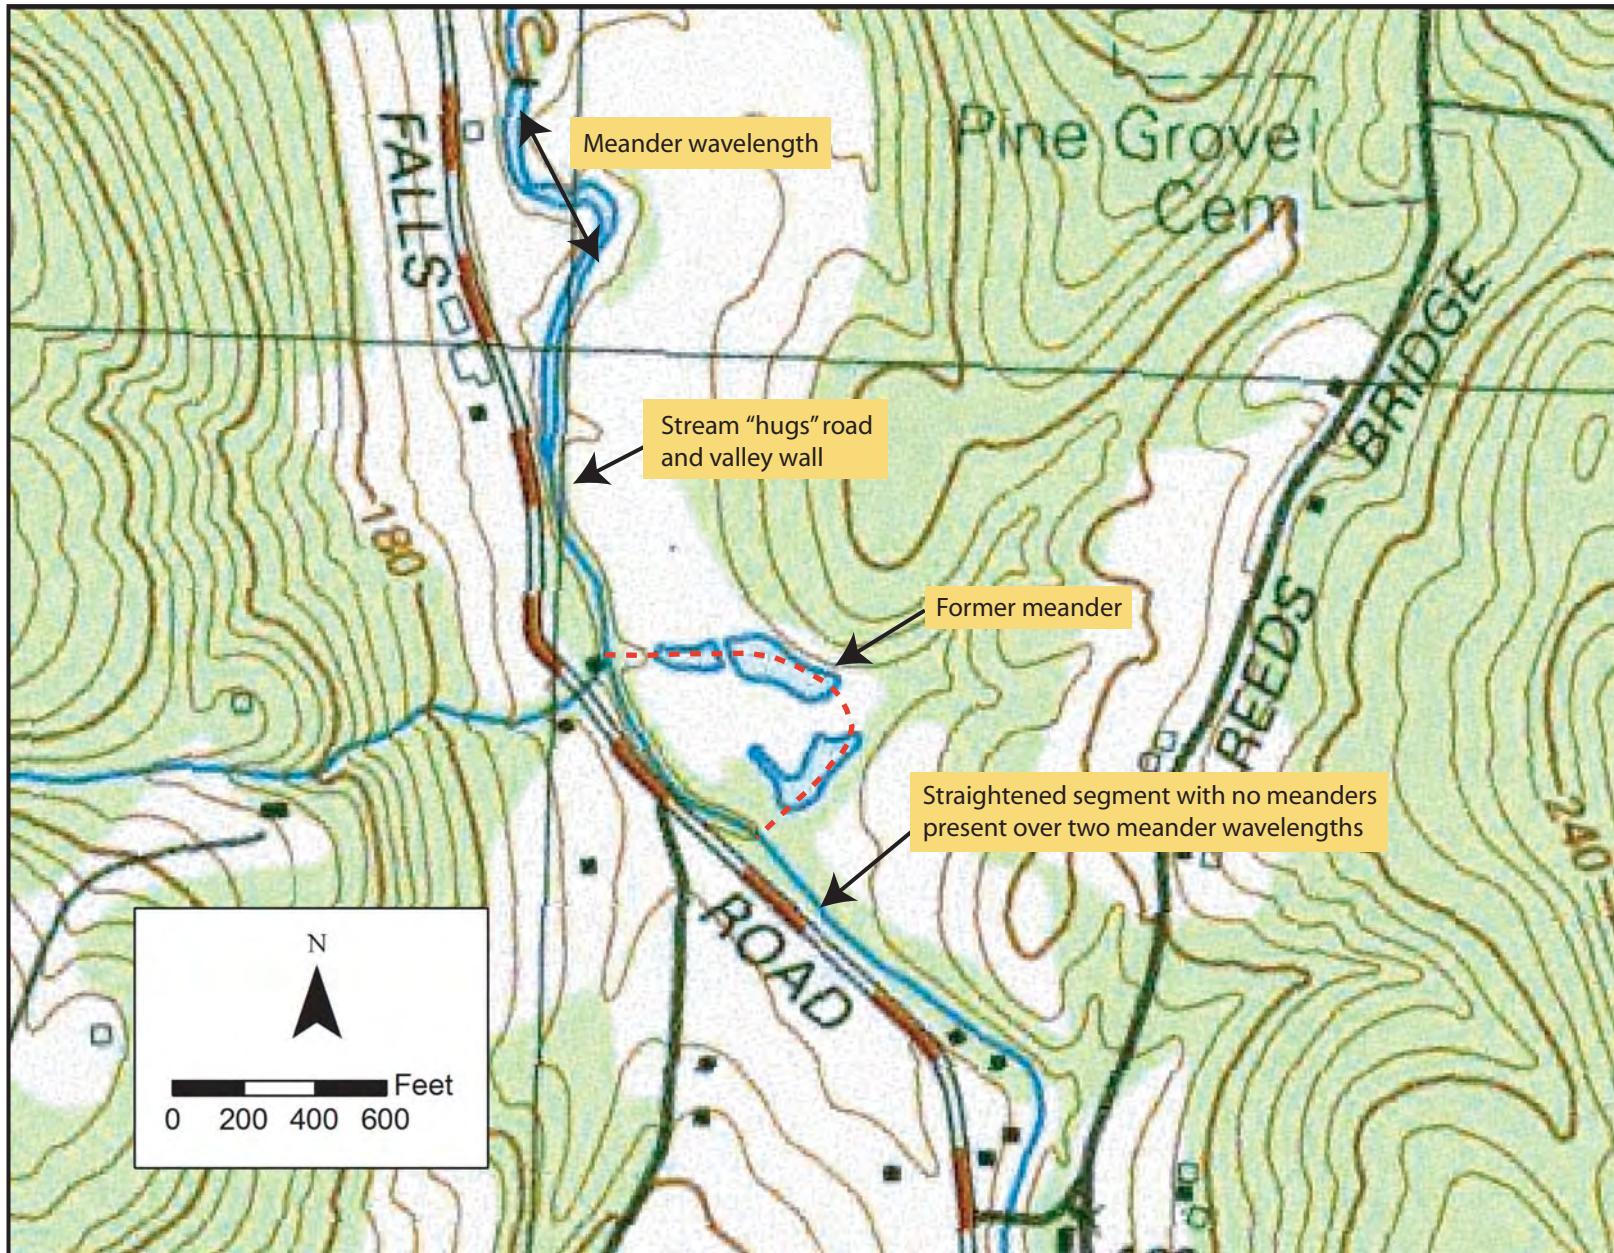
Figure 7. Evidence for artificial channel straightening on South River.

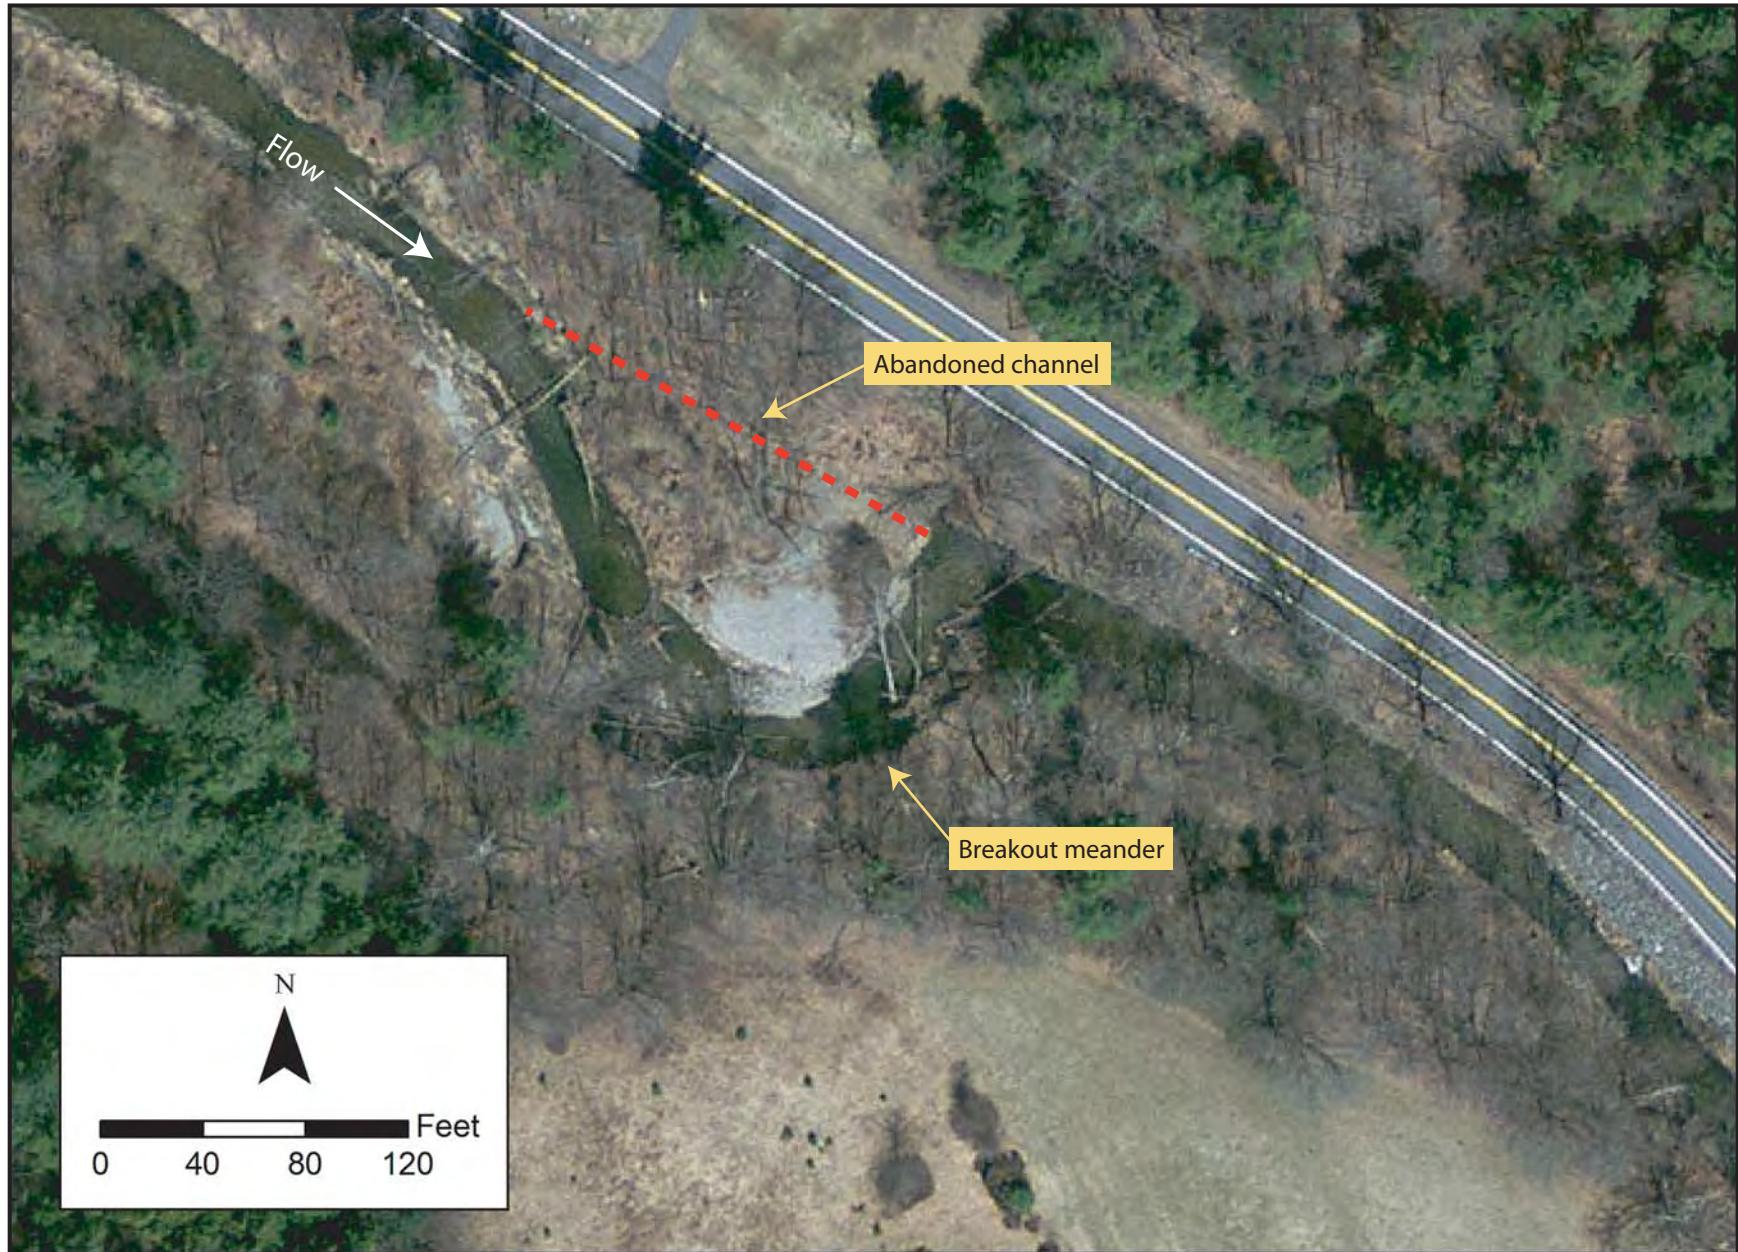
to this past straightening results in flood and erosion hazards that threaten the reach. For example, an enlarged mid-channel bar formed downstream of the recently channelized and armored segments, 18E and 18D, is diverting flow into the adjacent bank, creating a hazard to both Route 116 and the riparian landowner (Figure 8).

Figure 8. Reformed meander on straightened channel segment of South River.

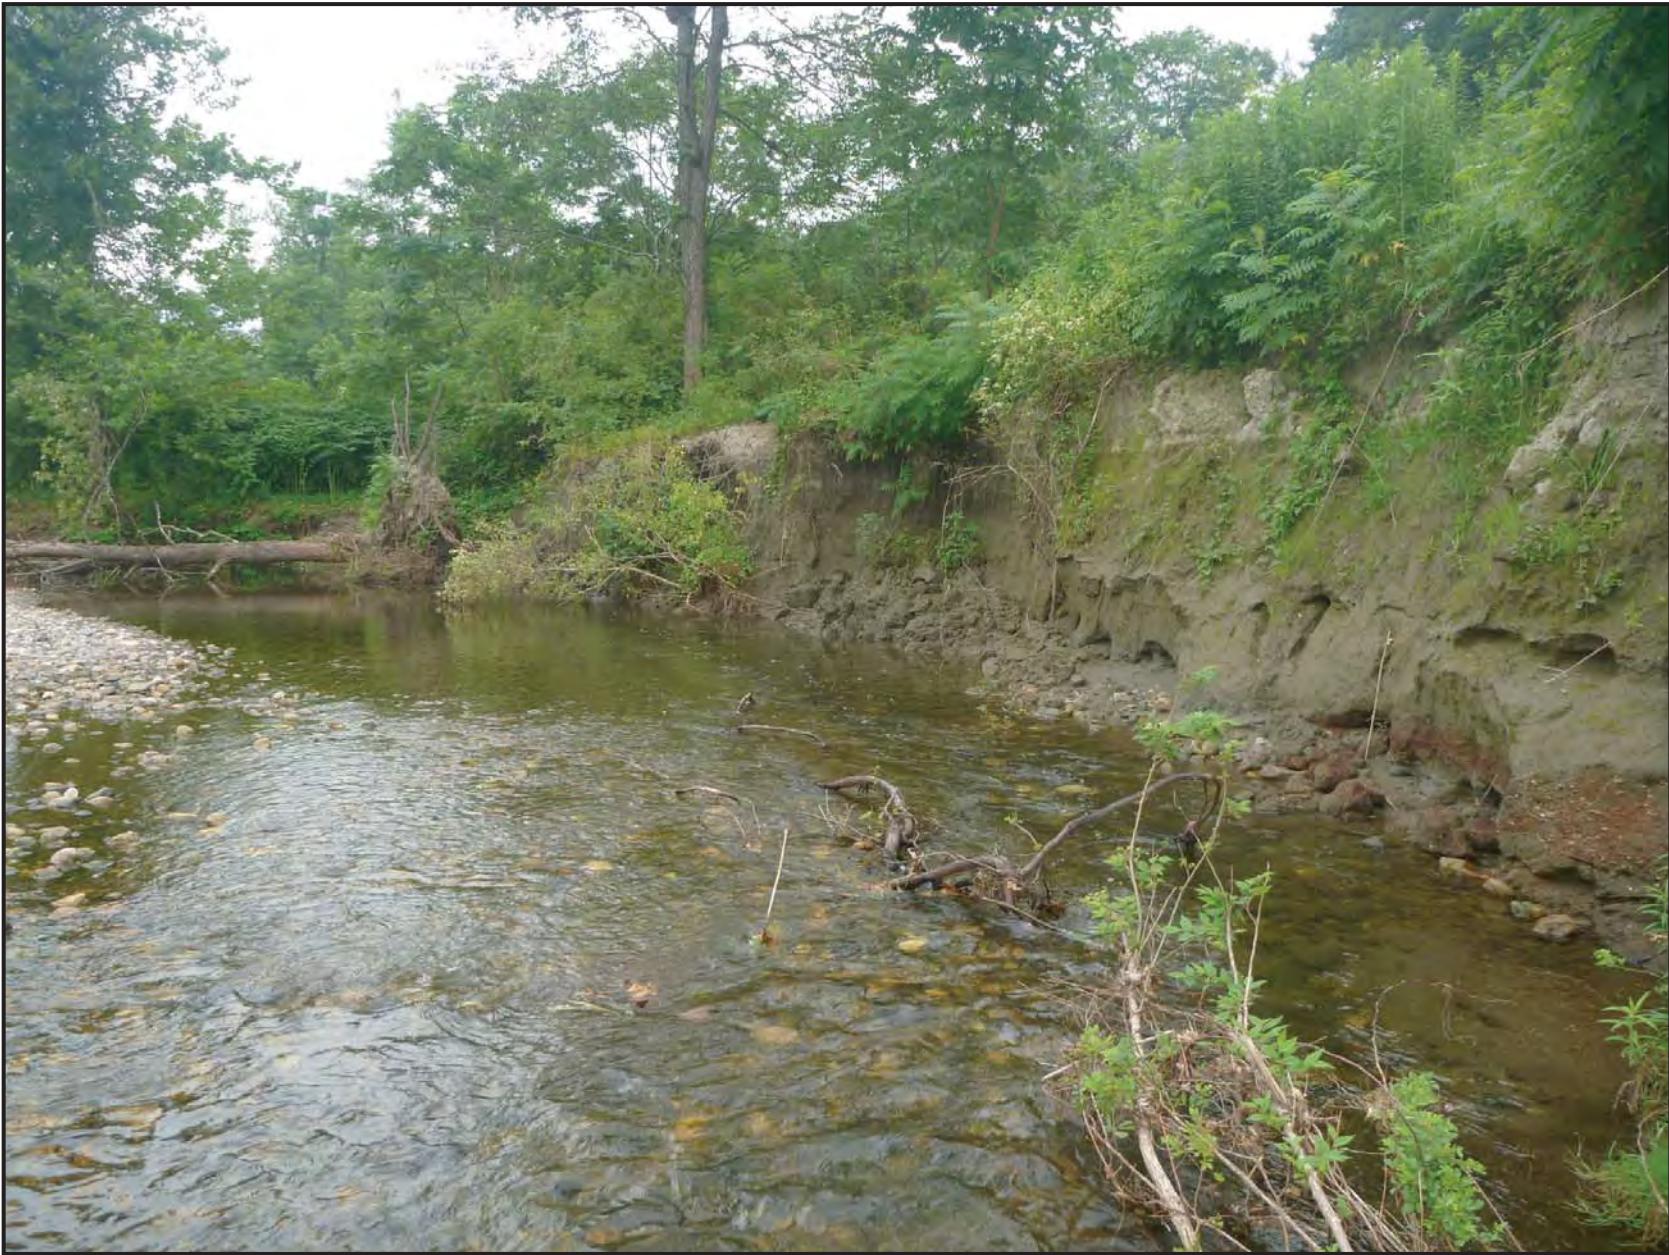
Figure 10. Impoundment sediments along an eroding bank exposed by channel incision through a former mill pond.

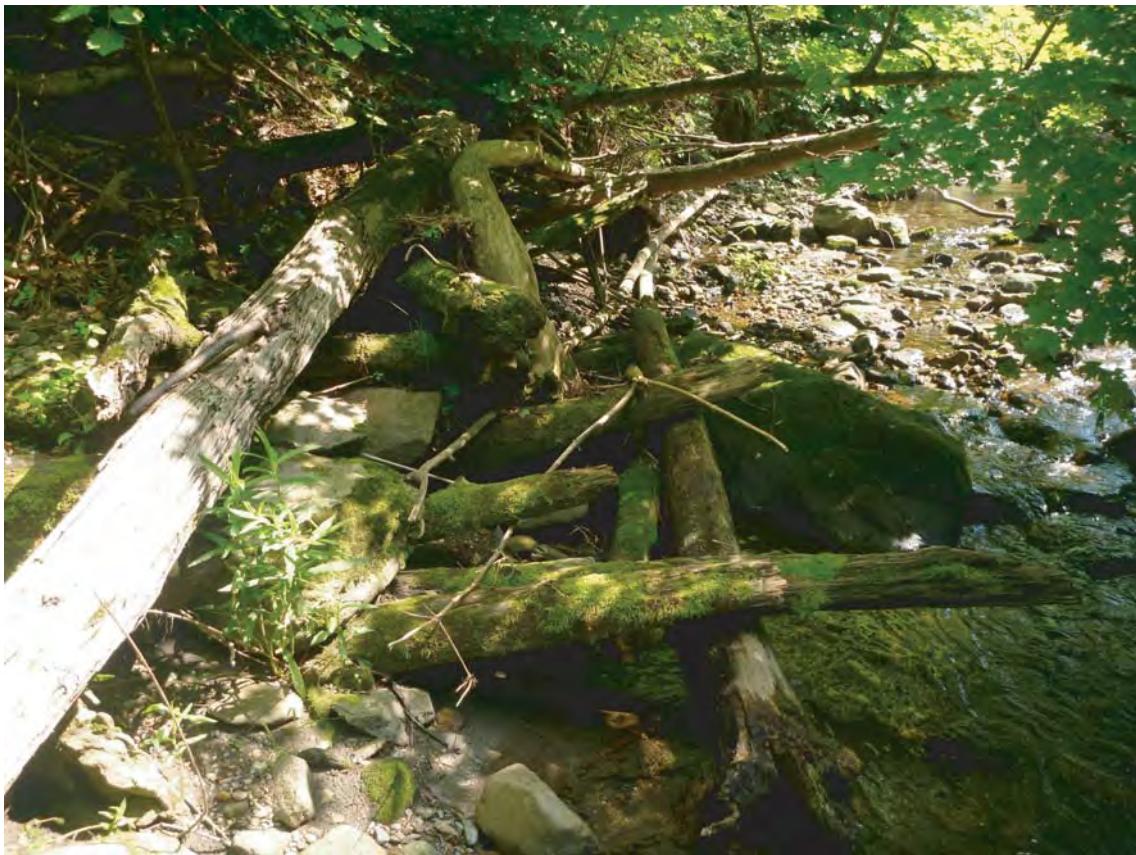
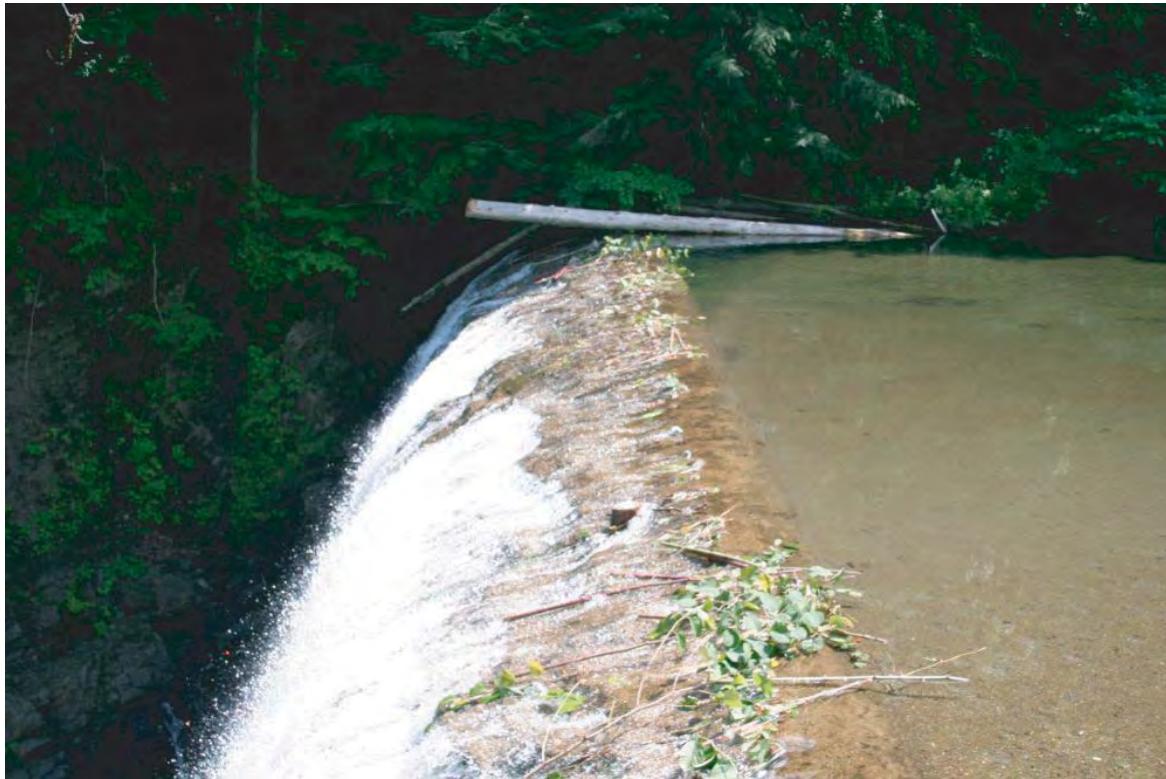
In addition to historical maps showing the location of former mill dams on South River (Figure 12 and Appendix 2), remnants of these and other dams are still visible in the field (Figure 13a). A total of 30 dams or remnants of dams were mapped on South River (Appendix 2). The older dams were primarily log crib structures (Figure 13a), but the largest existing dam near the downstream end of the river is of concrete construction (Figure 13b). Canals adjacent to the river that once led to mill buildings are frequently observed with their upstream ends beginning at the sites of former mill dams (Figure 12).

The majority of the mill dams have fallen into disrepair and have been breached (Figure 13a) with the impoundment sediments, in some cases, providing the only remaining evidence on the ground of the dams' former presence. Where the dams have been breached, the river has carved through the layers of accumulated silt up to 12 ft deep, giving rise to long lengths of eroding banks of readily transported fine-grained sediment (Figure 10). The channels incising through these former impoundment sediments are still evolving towards an equilibrium channel condition, so the bank erosion is likely to continue for an extended period of time and lead to high sediment loading downstream (see Section 2.7 below). In contrast, in those few cases where the former mill dams are still standing, the impounded area upstream is characterized by wide shallow channels prone to rapid migration as flow is diverted around the large point bars and mid-channel bars deposited in the low velocity zones upstream of the intact dams (Figure 14).

Figure 13. Former dams on South River are a) primarily log crib structures while b) the largest existing dam is made of concrete.

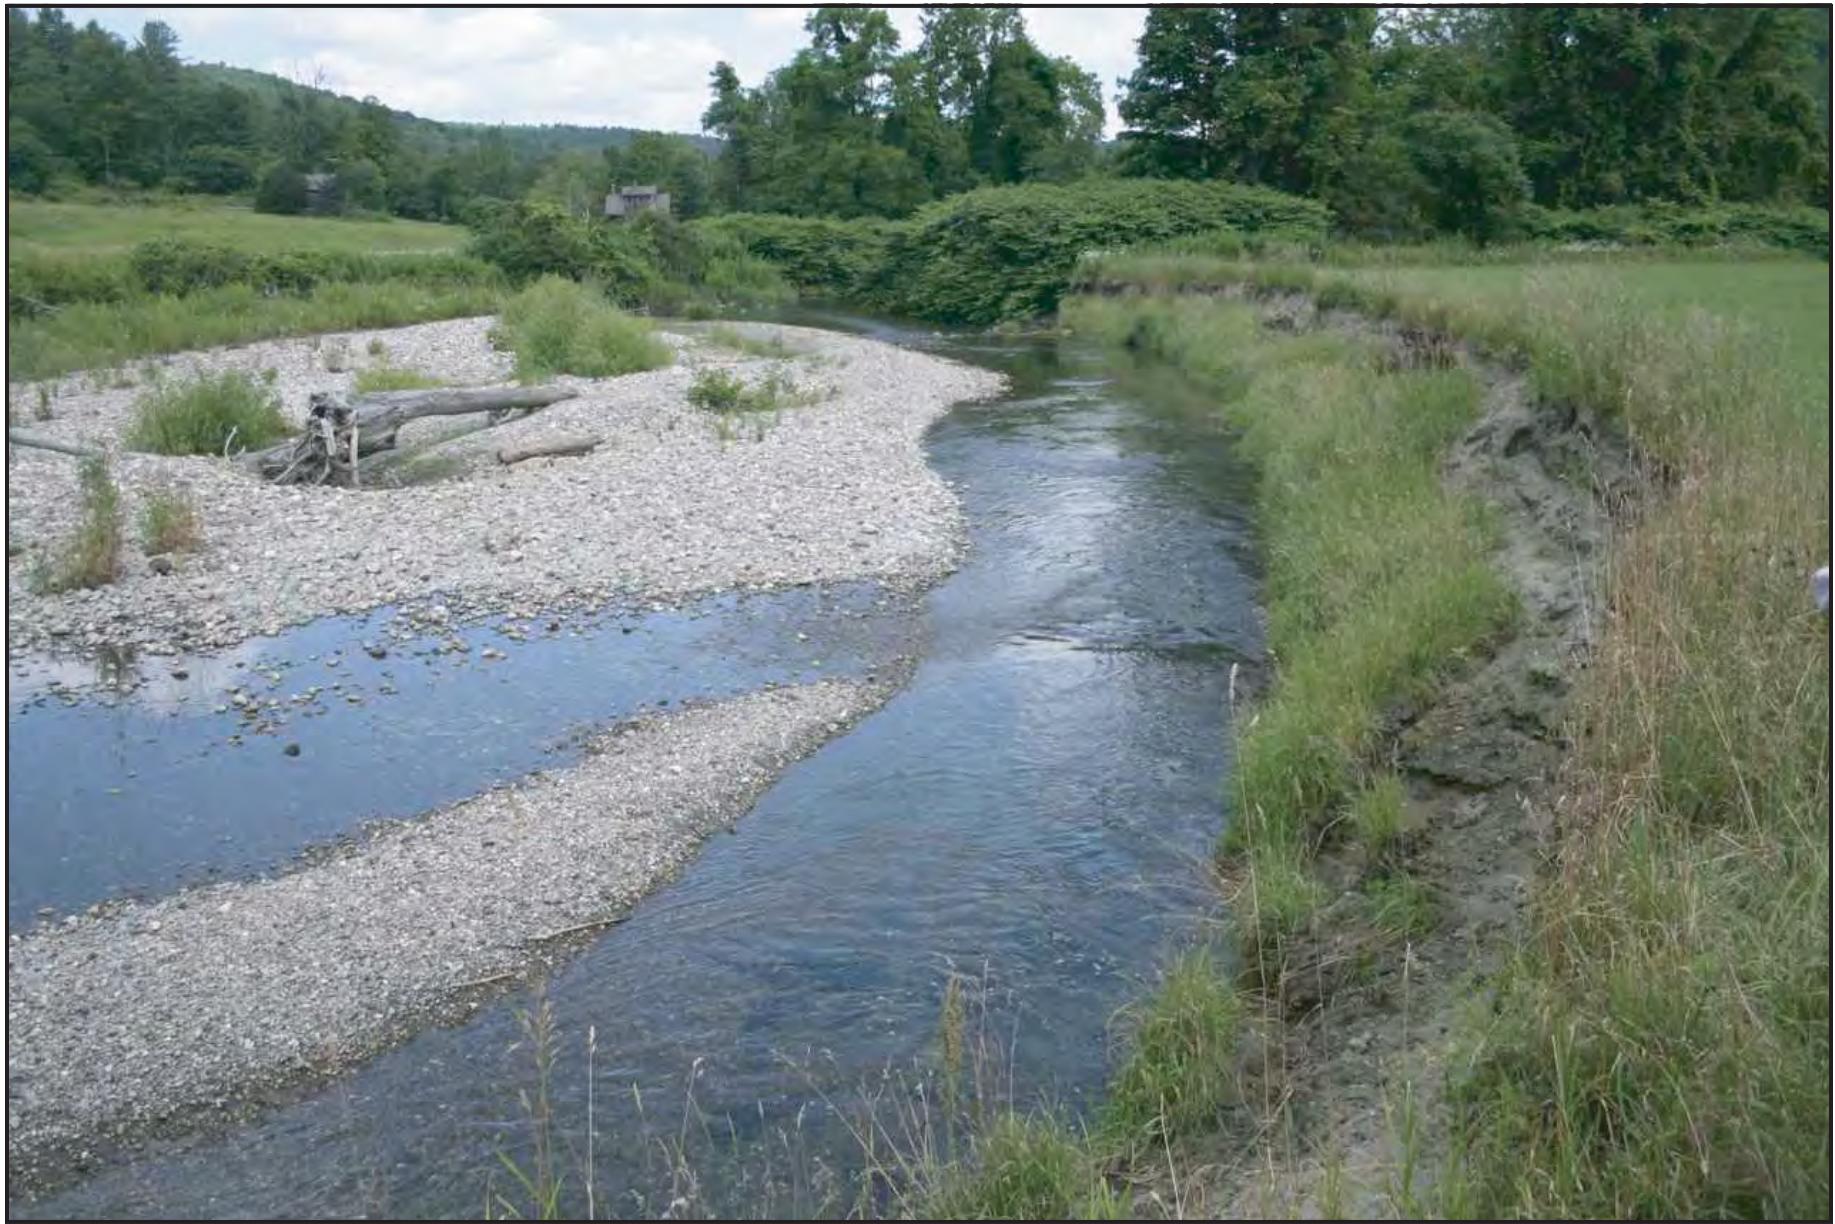
Figure 14. Large bars form in the wide shallow channels developed in an impoundment area upstream of an old mill dam that remains intact.

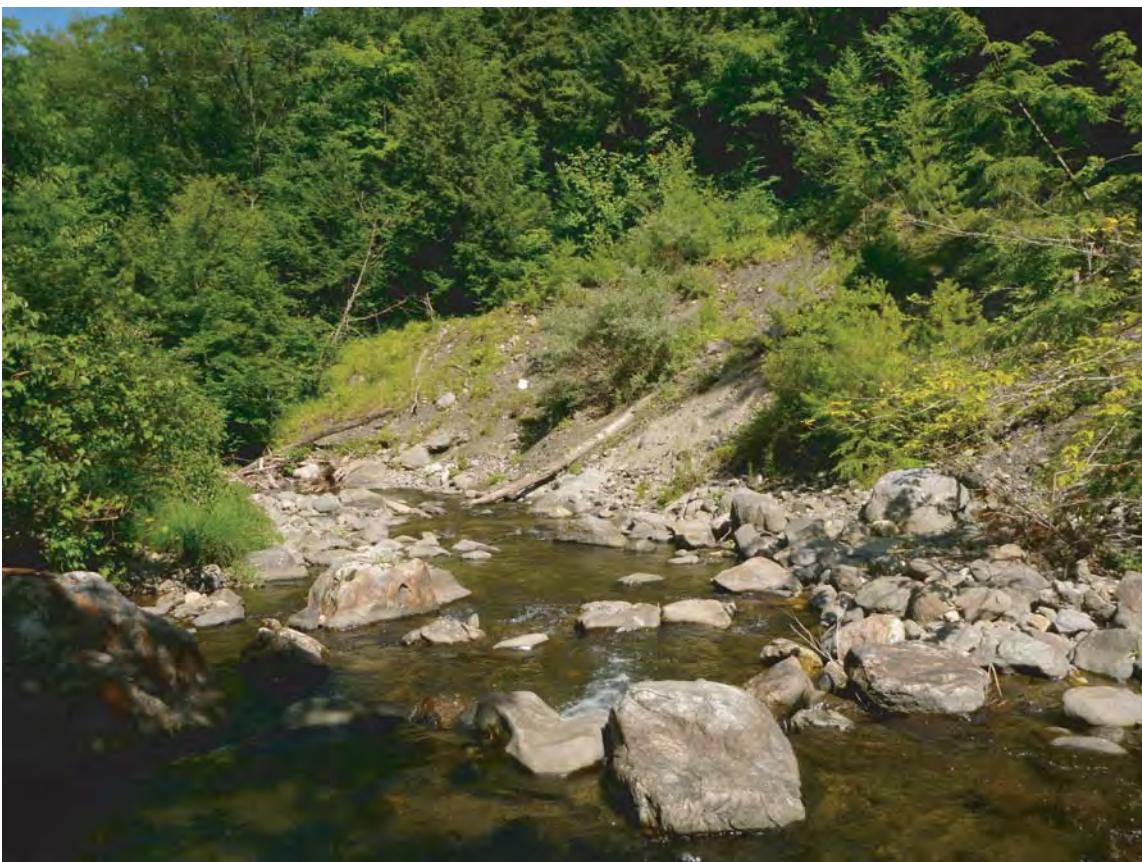
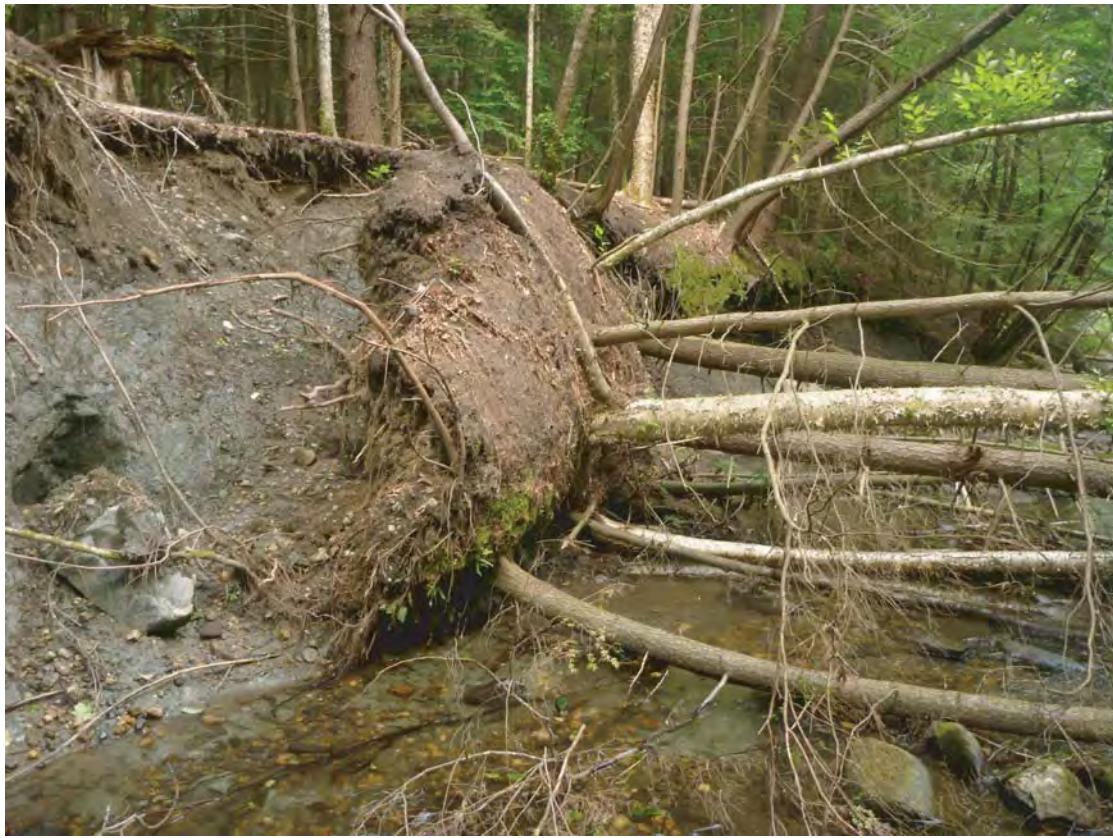
the river flows against the valley sides and encounters high banks of glacial deposits, the river is capable of initiating landslides, larger scale mass failures that rapidly introduce large amounts of sediment and wood into the channel (Figure 15). Forty six mass failures are present on South River with most of these mass wasting events found in narrowly confined reaches of the river where the river is more likely to flow against the valley sides (Table 2 and Appendix 1).

Large pieces of wood (greater than 0.5 ft diameter and 6.0 ft in length) are found on average every 43 ft along the river (122 pieces/mi) (Table 2). While this figure is below the 175-225 pieces/mi believed to have occurred naturally on northeastern rivers (McKinley et al., no date), the amount of wood in the channel is considerable given the long history of sawmills and logging in the watershed. Wood is introduced to the channel through mass failures of high banks (Figure 15) and less commonly by erosion of low banks.

Figure 15. Mass failures on South River introducing a) sediment and b) wood to the channel.

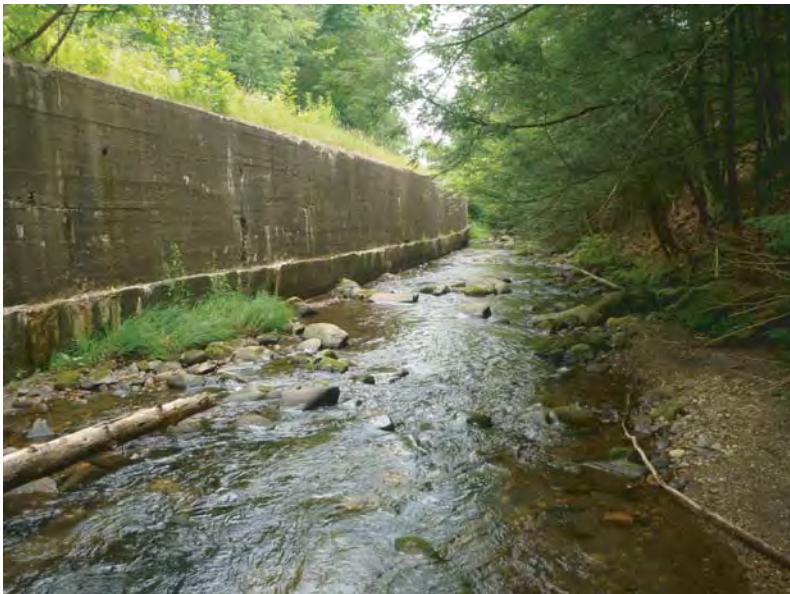
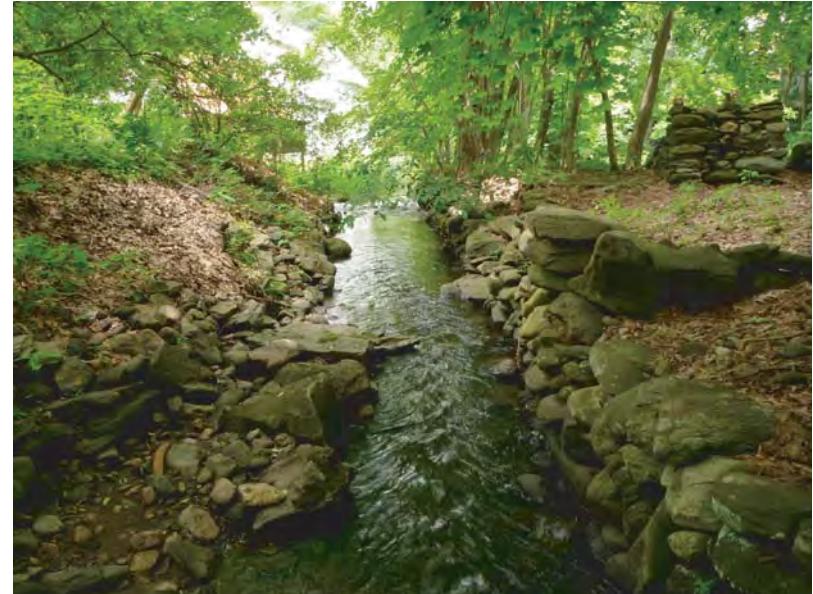
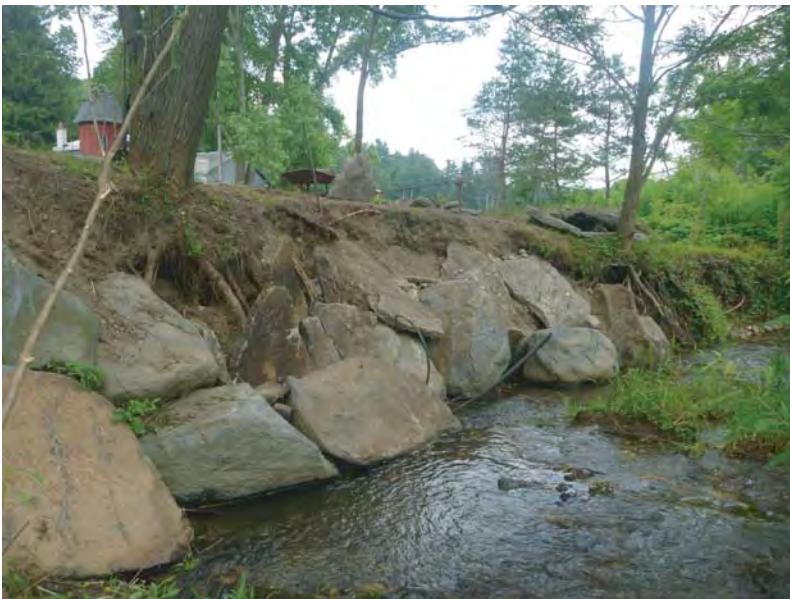
Concerns about erosion and its potential for land loss and infrastructure damage has led to the armoring of nearly 10 percent of the river's banks (Table 2). Armoring on South River comes in the form of concrete retaining walls found along portions of Route 116 (Figure 16a), stacked rock retaining walls (Figure 16b), and more traditional rock riprap (Figure 16c). A geocell retaining wall filled with soil to support plant growth was built upstream of the Main Street bridge in Conway (Figure 4a), but was washed away less than one month after completion during Tropical Storm Irene in August 2011 (Figure 4b) and replaced with boulder riprap (Figure 4c). Bank armoring usually extends over only the bank, but in one location (Segment 15A) the riprap was also placed over much of the channel bed. While protecting property and infrastructure, bank armoring prevents natural channel adjustments that are important for creating aquatic habitat and establishing long-term channel stability. Consequently, the use of bank armoring should be limited.

Figure 16. Bank armoring on South River comes in the form of a) concrete retaining walls, b) stacked rock retaining walls and c) rock riprap.

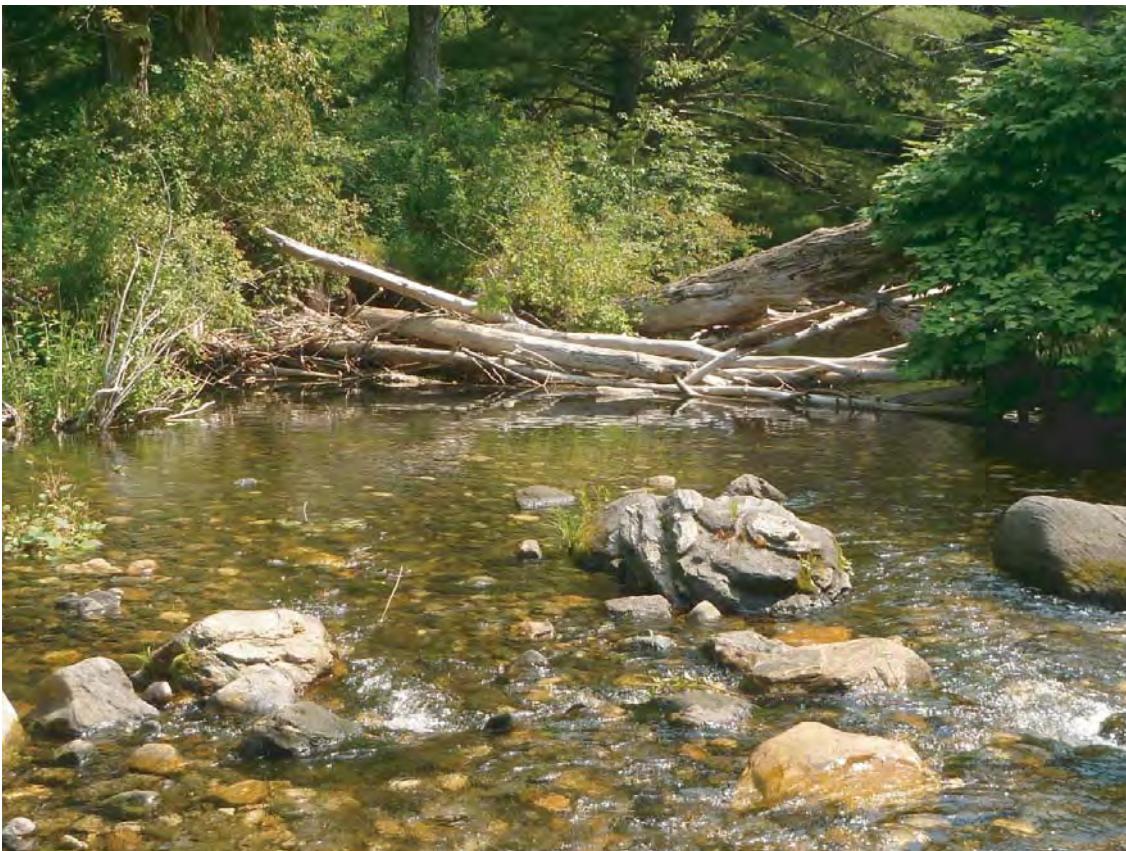
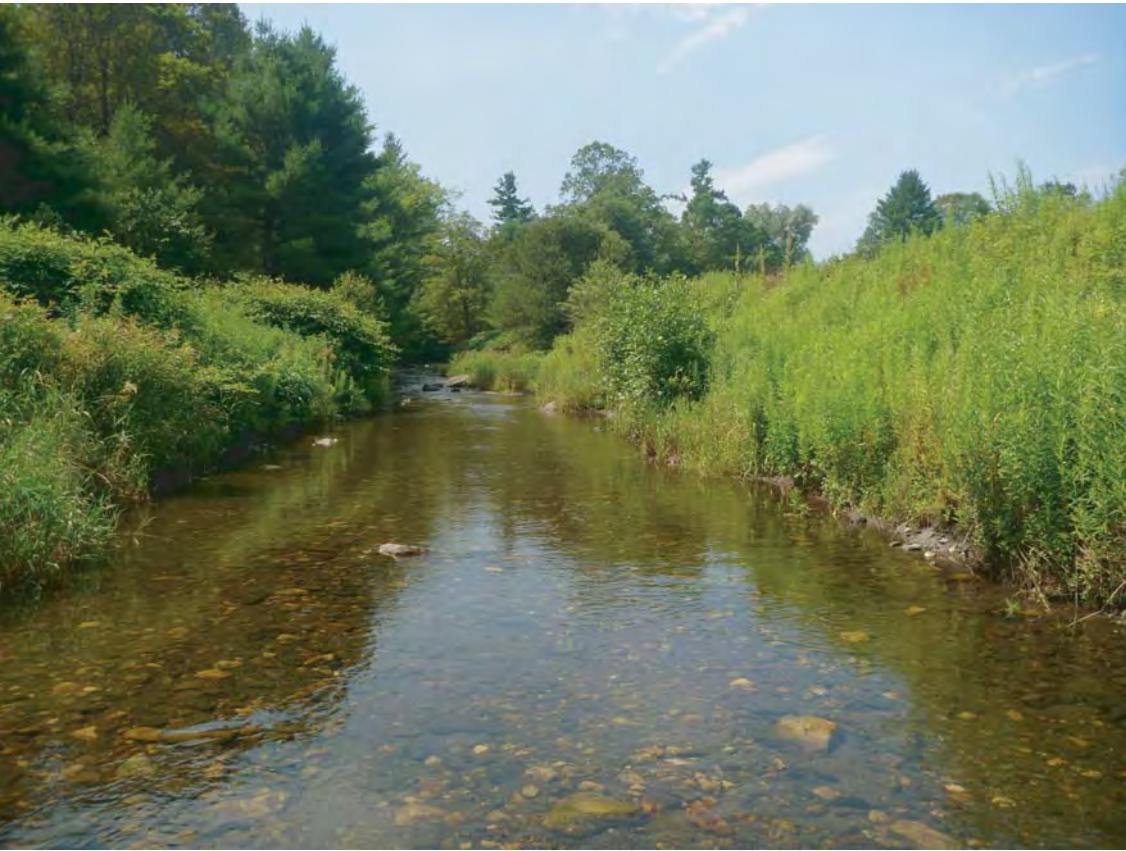
Figure 17. Wood is unevenly distributed on South River with a) large concentrations in short segments of channel and b) long lengths of channel devoid of wood entirely.

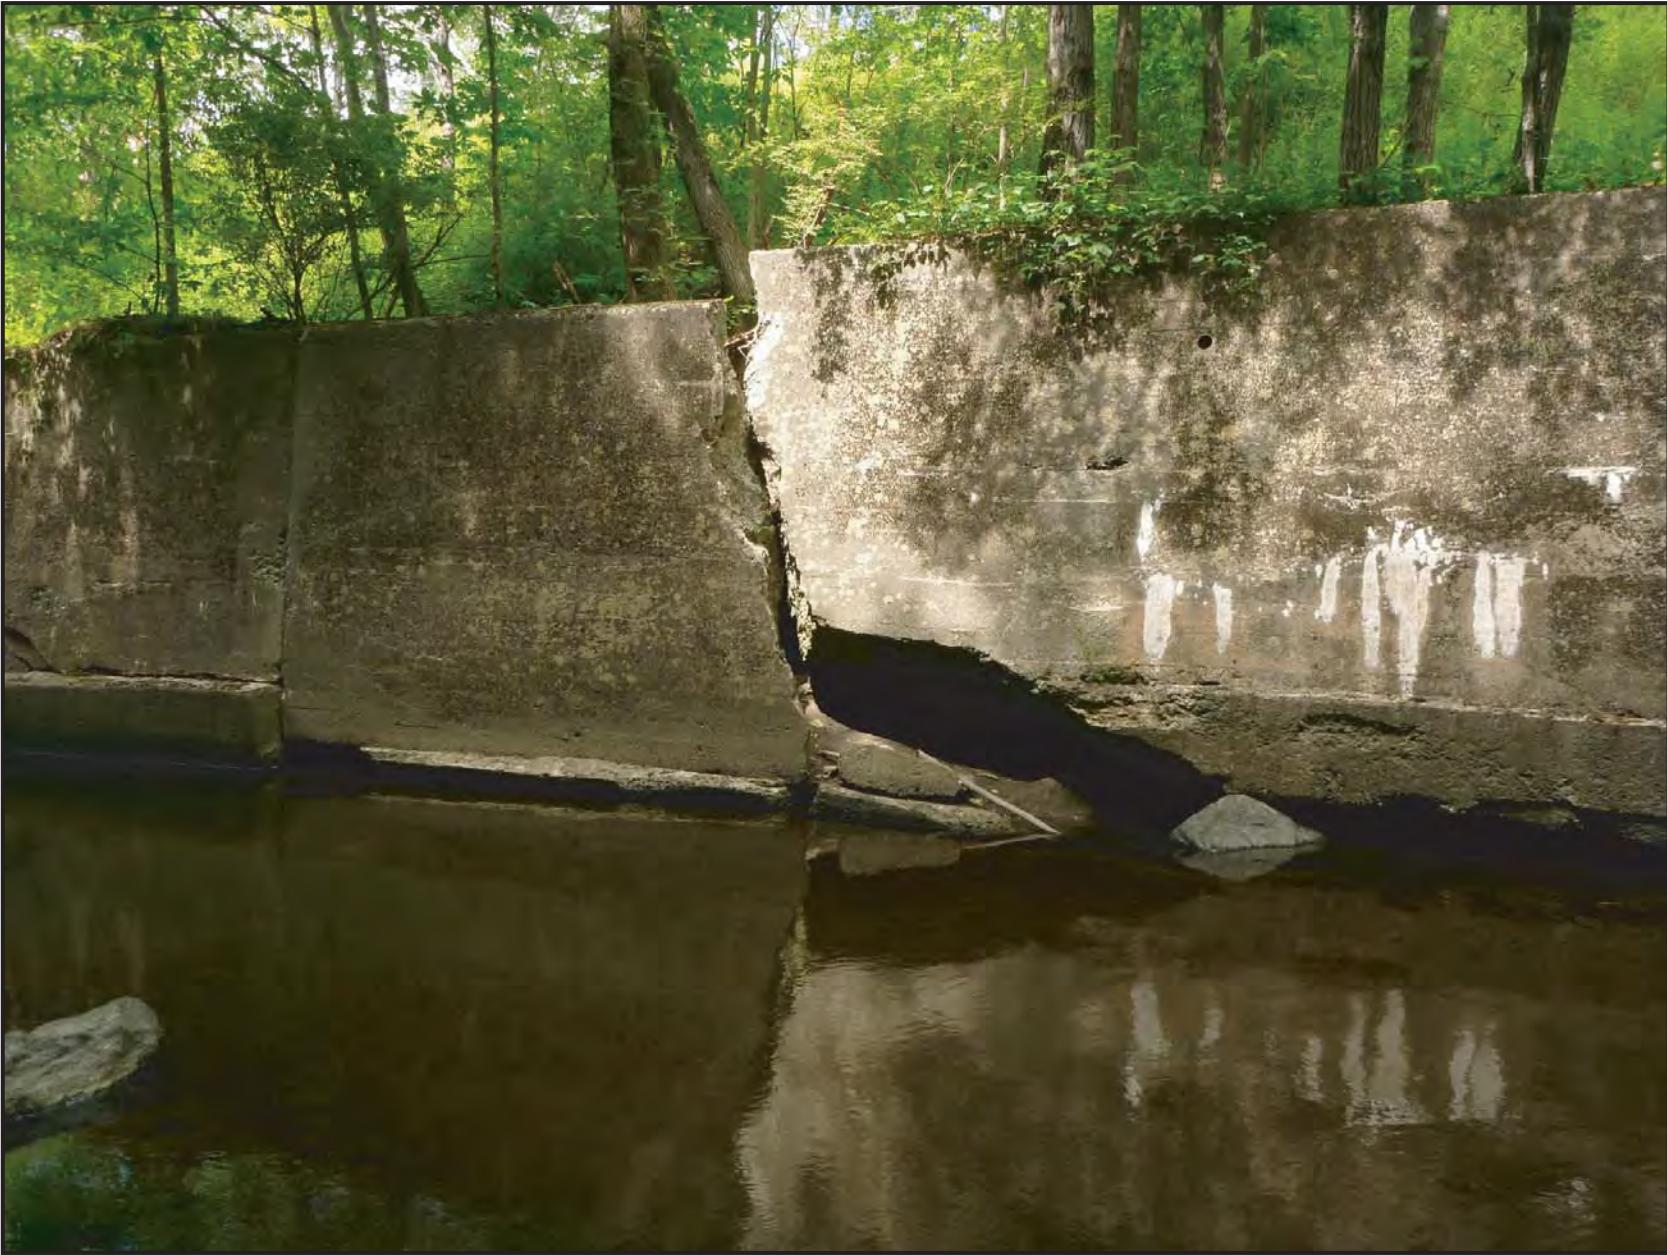
Figure 18. Scour undermines a concrete retaining wall on South River in Conway.

Department of Transportation to repair or replace the walls with additional scour protection (Field, 2010 and 2013). As meanders continue to develop along artificially straightened segments of the channel (see Section 2.7 below), more pools are likely to develop as the plane-bed morphology is transformed to pools and riffles.
