Fluvial Geomorphic Assessment of the South River Watershed, MA

Franklin Regional Council of Governments
Greenfield, MA

John Field
Field Geology Services
Farmington, ME

February 2013

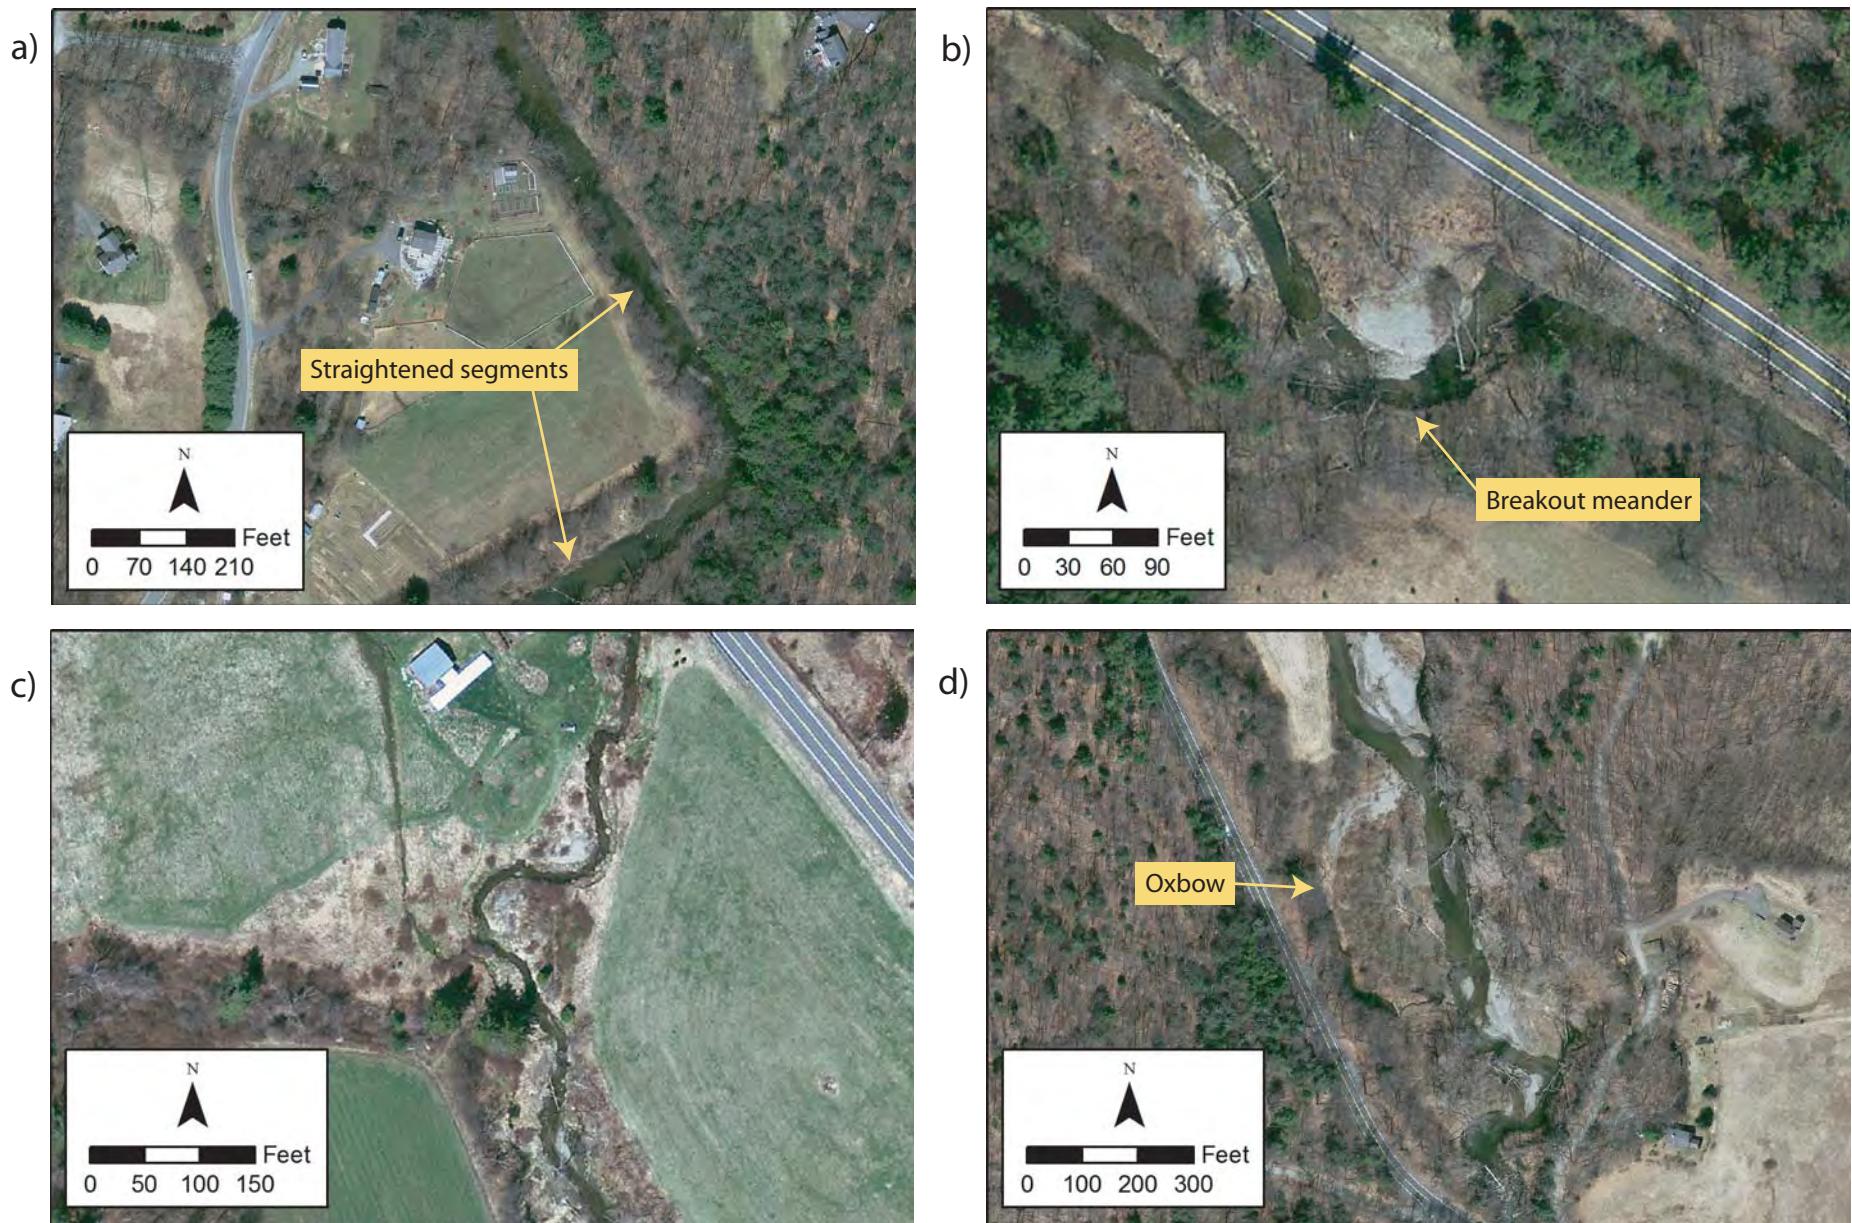
Nearly the entire length of the unconfined channel segments on South River were artificially straightened in the past (see Section 2.4 above and Appendix 1). Artificially straightened channels in alluvial reaches are inherently unstable due to the increase in channel gradient and stream power associated with the shortened stream length. Over time, straightened stream channels undergo a series of channel adjustments that ultimately lead to the return of a stable, yet continually shifting, meandering planform that approximates the pre-straightening condition. As described in Section 2.4 above, the first stage in the evolution of straightened channels is the formation of an initial meander by either the buildout or breakout process with buildouts being the predominant process on South River. Sediment accumulation is the main driving force of meander reformation on South River, although wood and ice likely play a lesser role as well. The straightened channel configuration persists on many sections of South River with such segments prone to future meander formation (Figure 19a). The initial meanders to form are simple single bends that initially break away from the straightened channel, but ultimately reconnect to the straightened channel downstream (Figure 19b). Breakout meanders most readily develop where flows can easily overtop the channel banks such as in backwater areas behind constrictions (such as dams), low gradient reaches, or where bank heights are lowered through sediment deposition in the channel. Once meander development begins, further sediment deposition occurs in response to the increasing stream length with deposition on point bars on the inside of the meander bend and erosion on the outside. Through this process, meanders continue to grow and ultimately more complex multiple-bend meanders are created (Figure 19c).

The different stages of channel evolution that can be identified today at various points along South River (Figure 19) represent the stages that occur through time at a single location. Some areas progress through the stages of evolution much faster than others, explaining why fully redeveloped meanders are found in some locations while others remain in an artificially straightened condition. In general, evolution progresses faster where the channel has a lower gradient, lower banks, or where sediment accumulation is most rapid (i.e., at points of valley expansion or constriction). For these reasons, channel adjustments occur most quickly on channels within impounded areas, some segments experiencing, in only decades, all phases of Schumm's et al. (1984) channel evolution model: channel incision, widening, and meander formation. Understanding these processes of channel evolution can be used to anticipate the types, rates, and location of future channel adjustments, thus playing an important role in the restoration planning process (see Section 3.0 below).

Figure 19. Artificially straightened segments on unconfined channels of South River evolve through several stages from a) straightened segments to b) segments with single bends that reconnect to the straightened channel to c) segments with multiple bends and to finally d) segments with migrating fully reformed meanders where oxbows may develop as meanders are ultimately cutoff.

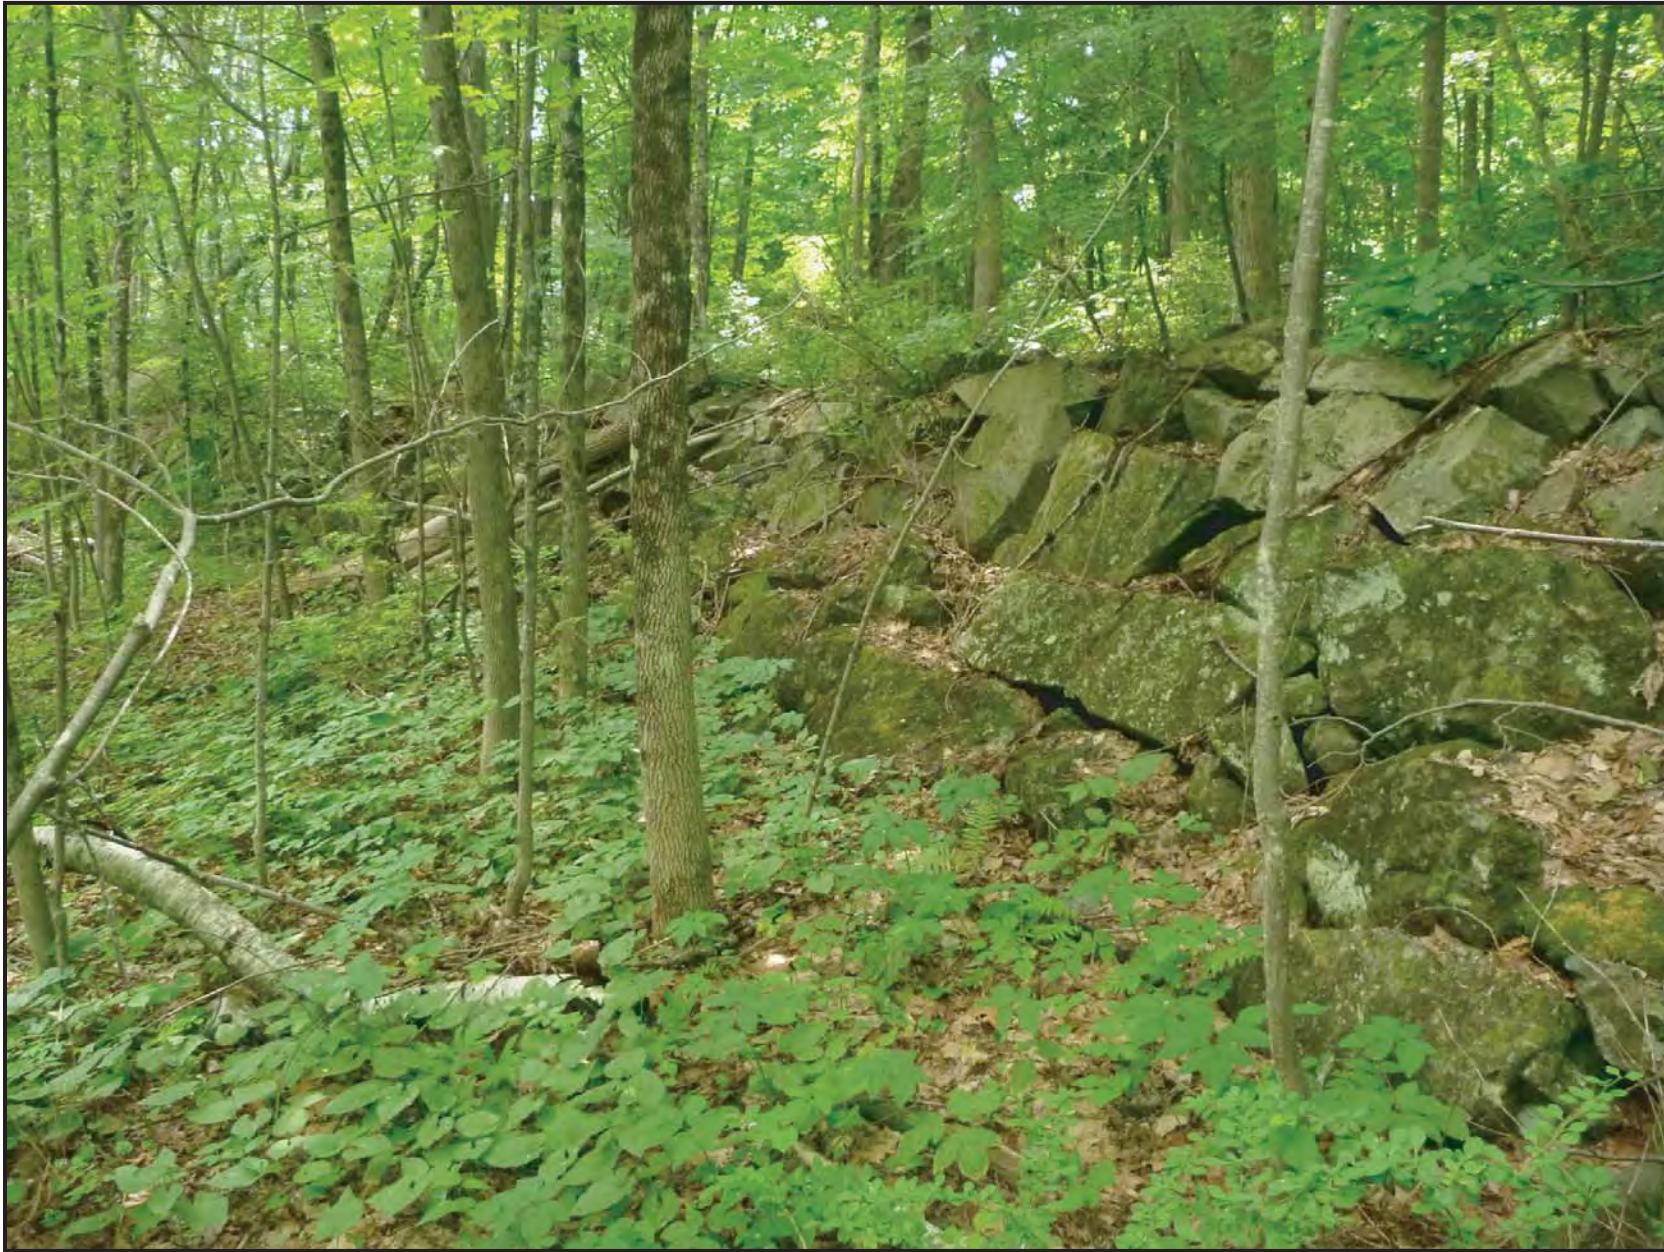
Figure 20. Berm constructed of large granite blocks cuts off the channel's floodplain access immediately upstream of the Main Street bridge in Conway.
