Fluvial Geomorphic Assessment of the South River Watershed, MA

Franklin Regional Council of Governments
Greenfield, MA

John Field
Field Geology Services
Farmington, ME

February 2013

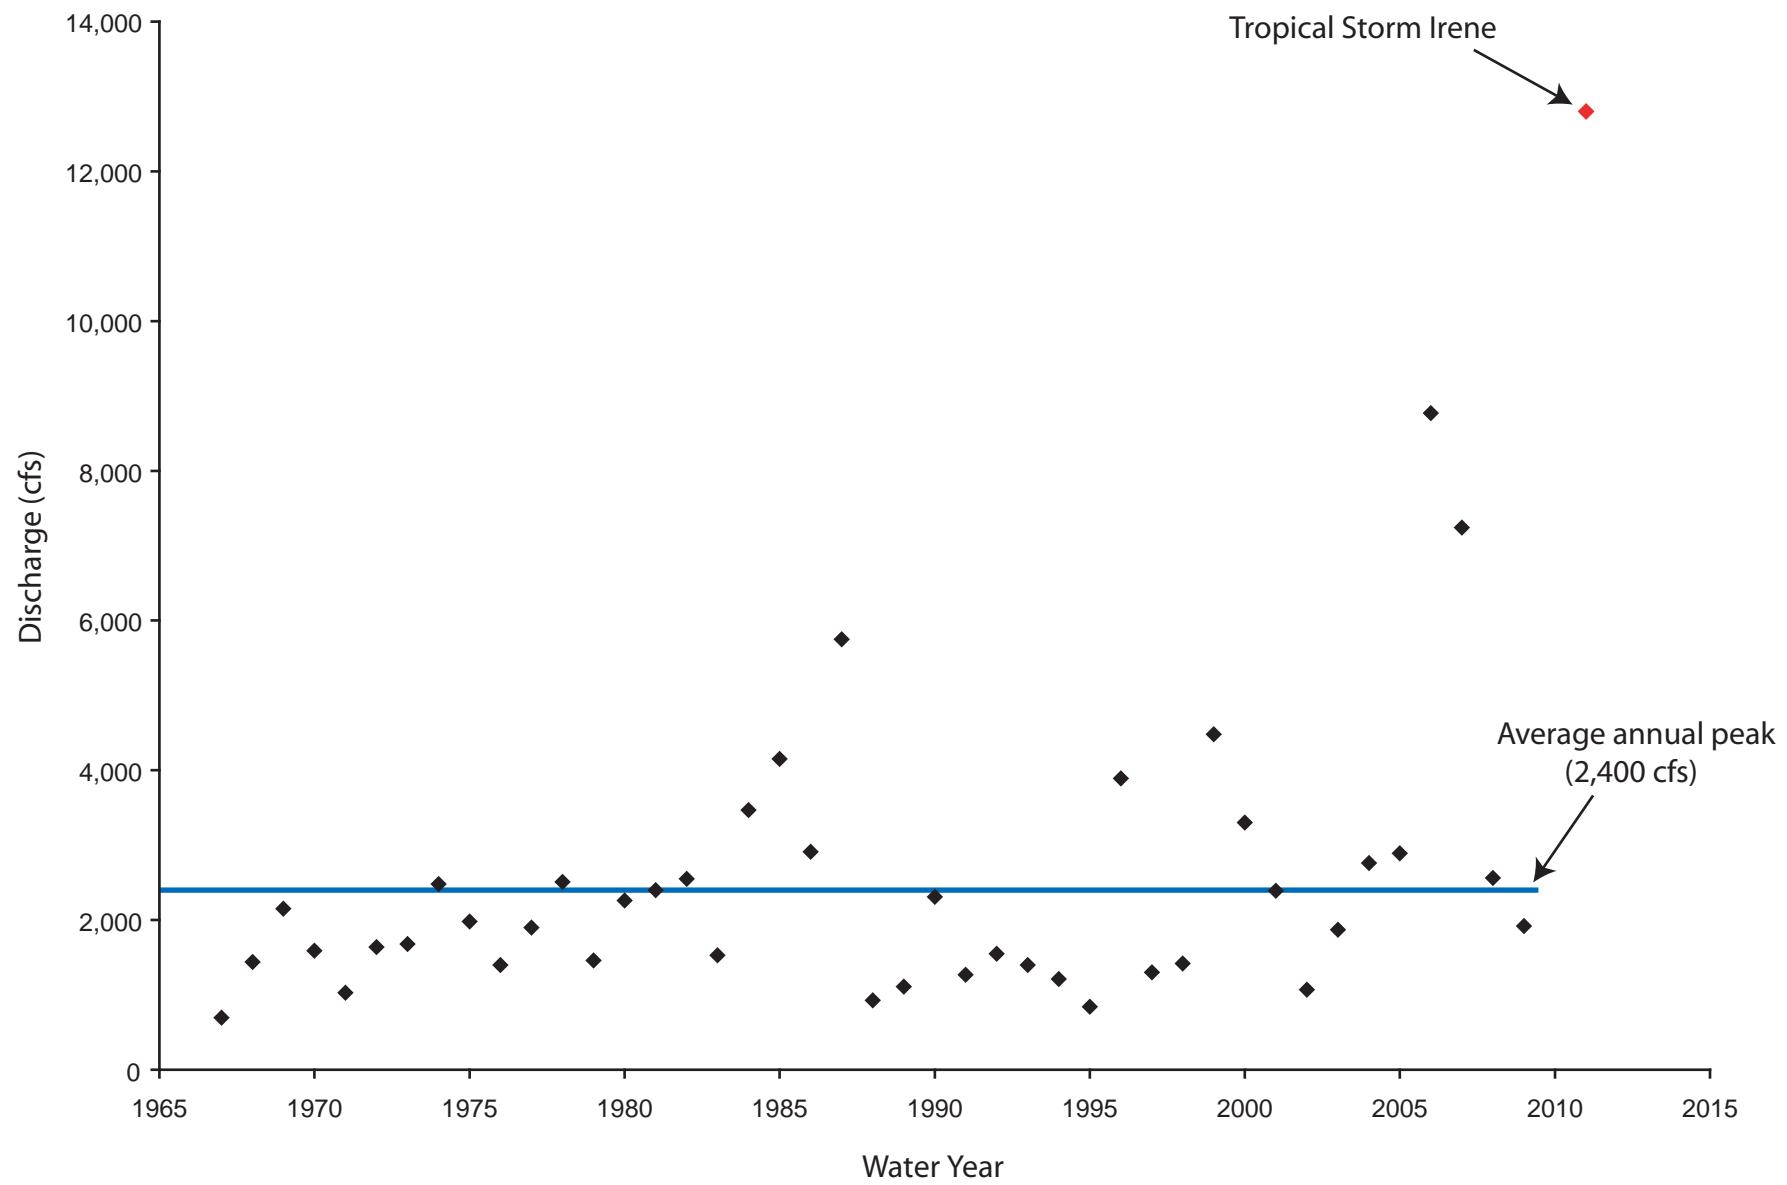
The USGS maintains a stream gage just upstream of the lower Reeds Bridge Road bridge in Segment 7A. The peak discharge data from the gauge are shown in Figure 3.

Figure 3. Annual peak discharge data for the South River including the historic maximum of 12,800 cfs recorded during Tropical Storm Irene on August 28, 2011.

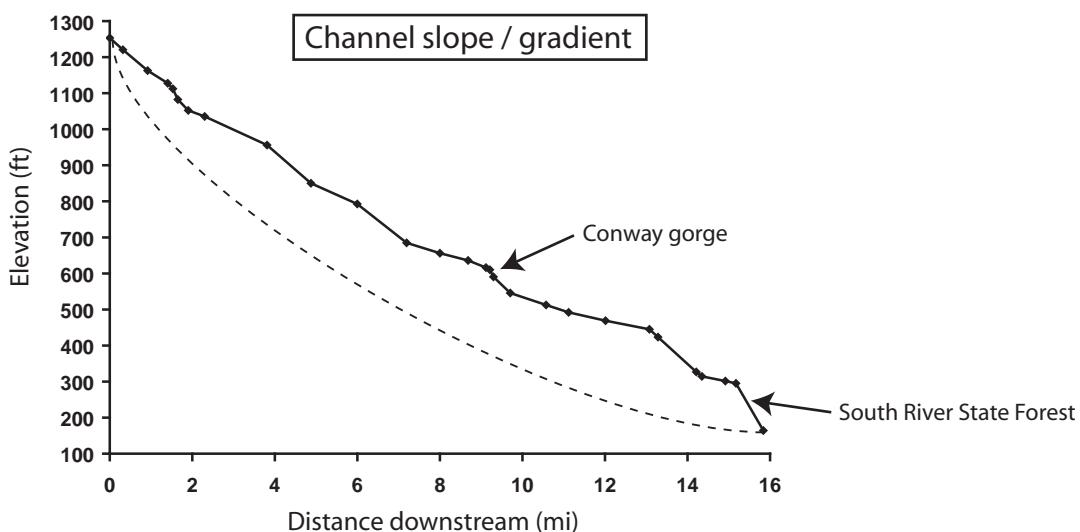
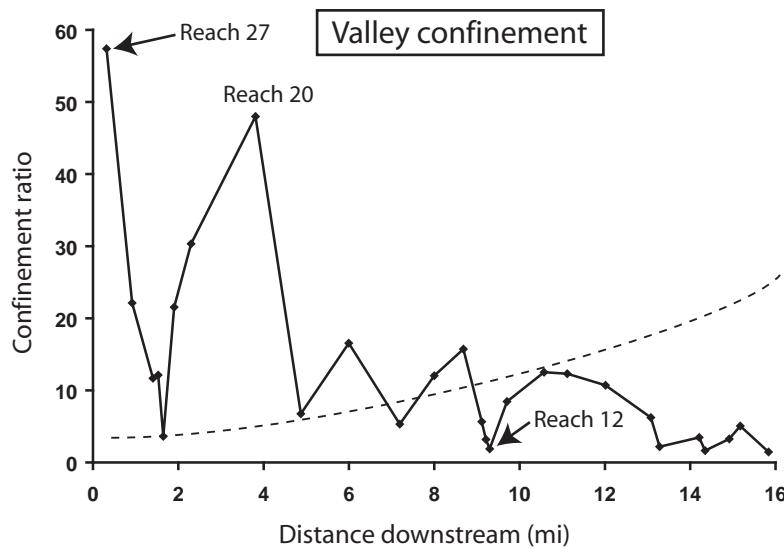
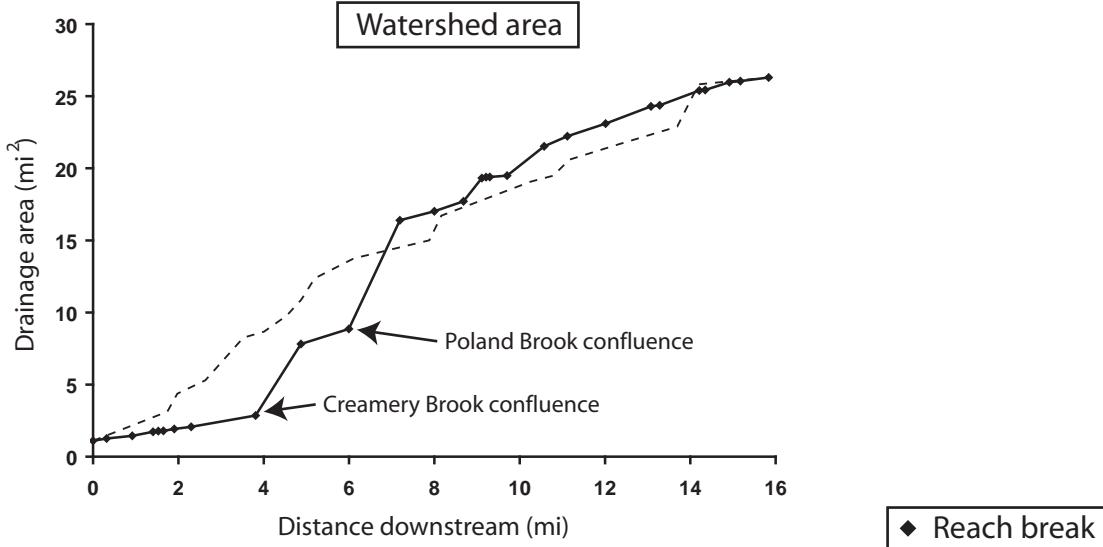
Figure 6. The complex geology and glacial history of South River gives rise to abrupt changes in a) slope, b) confinement, and c) watershed area along the length of the river. Note: dashed lines represent an idealized river equilibrium condition.

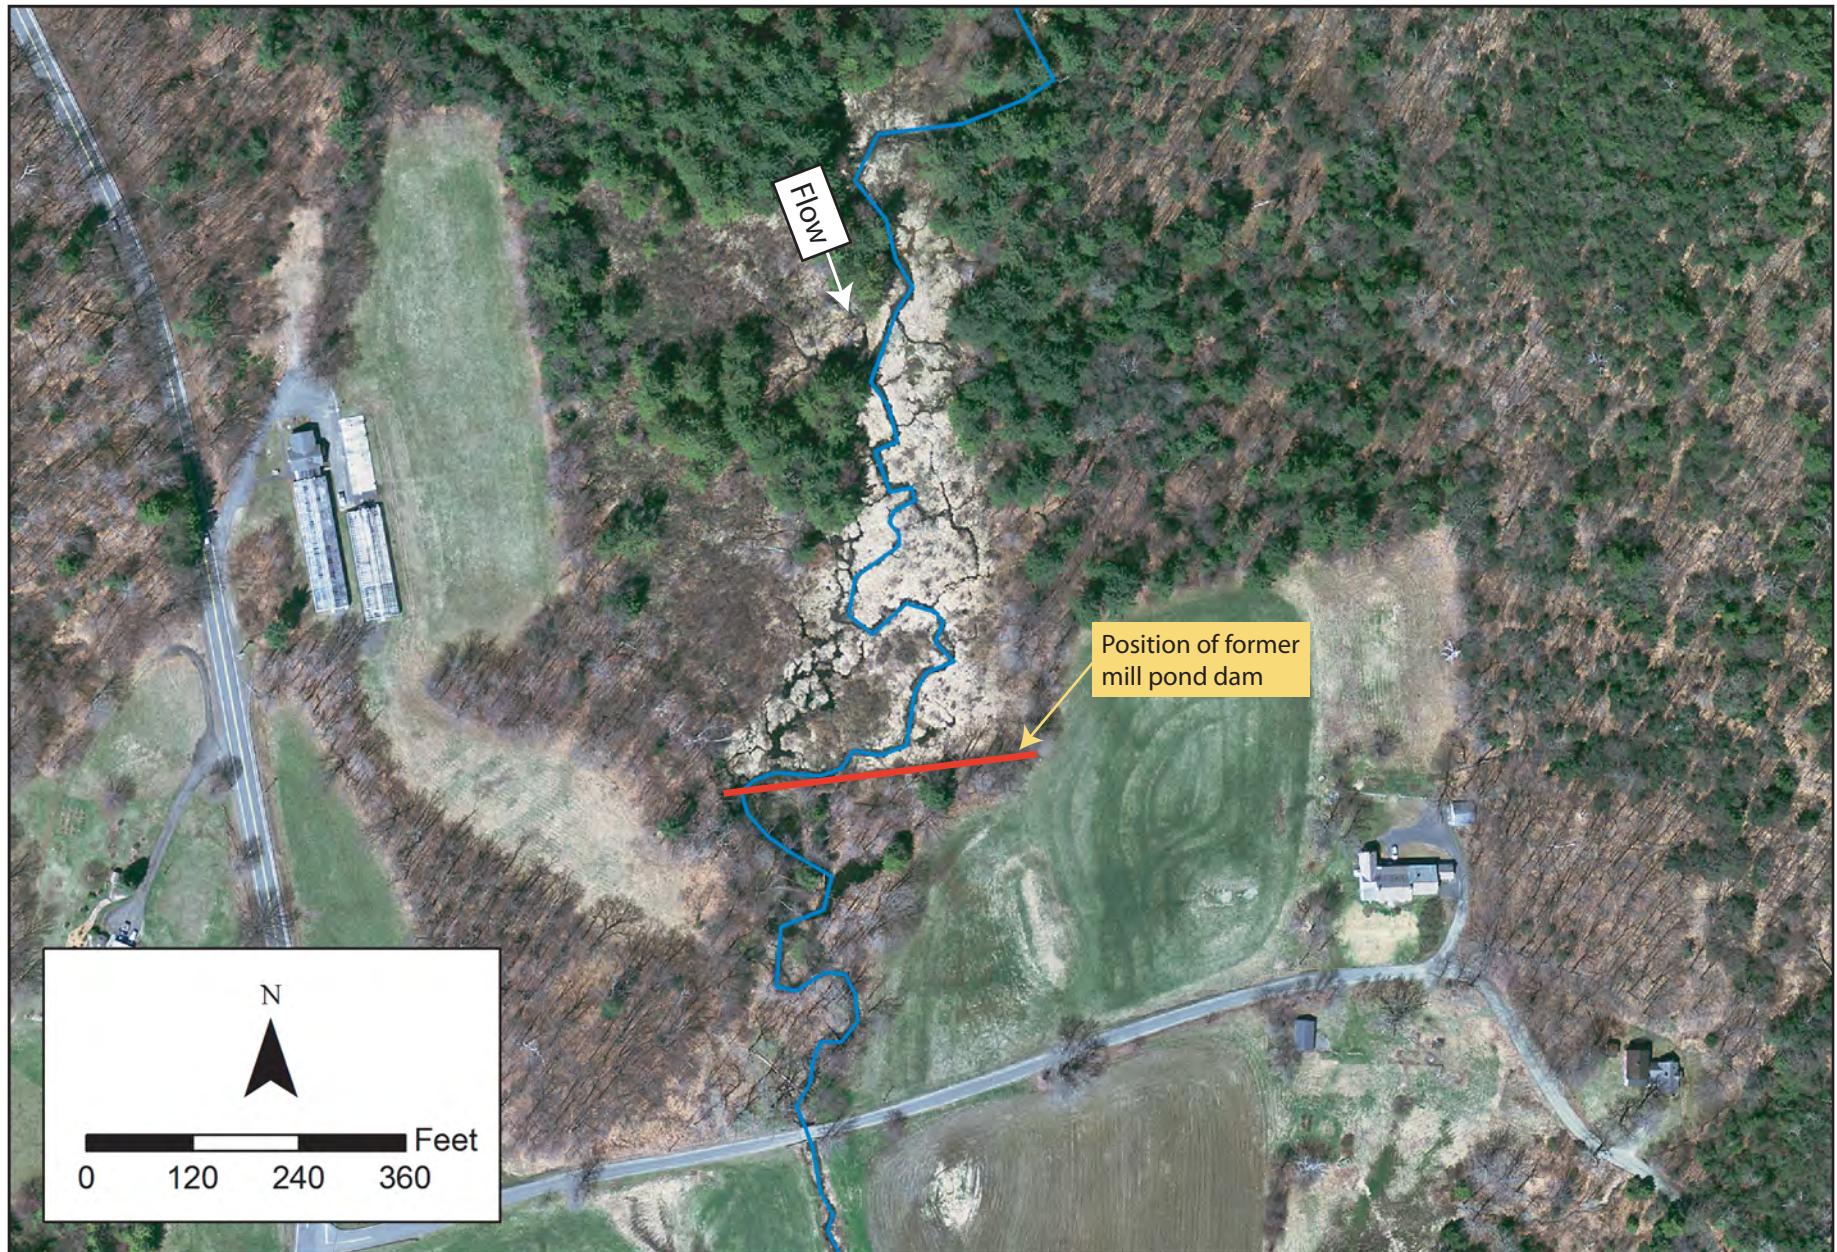
Figure 9. The position of former mill ponds can be identified on aerial photographs by the lighter tones associated with fine-grained impoundment sediments.

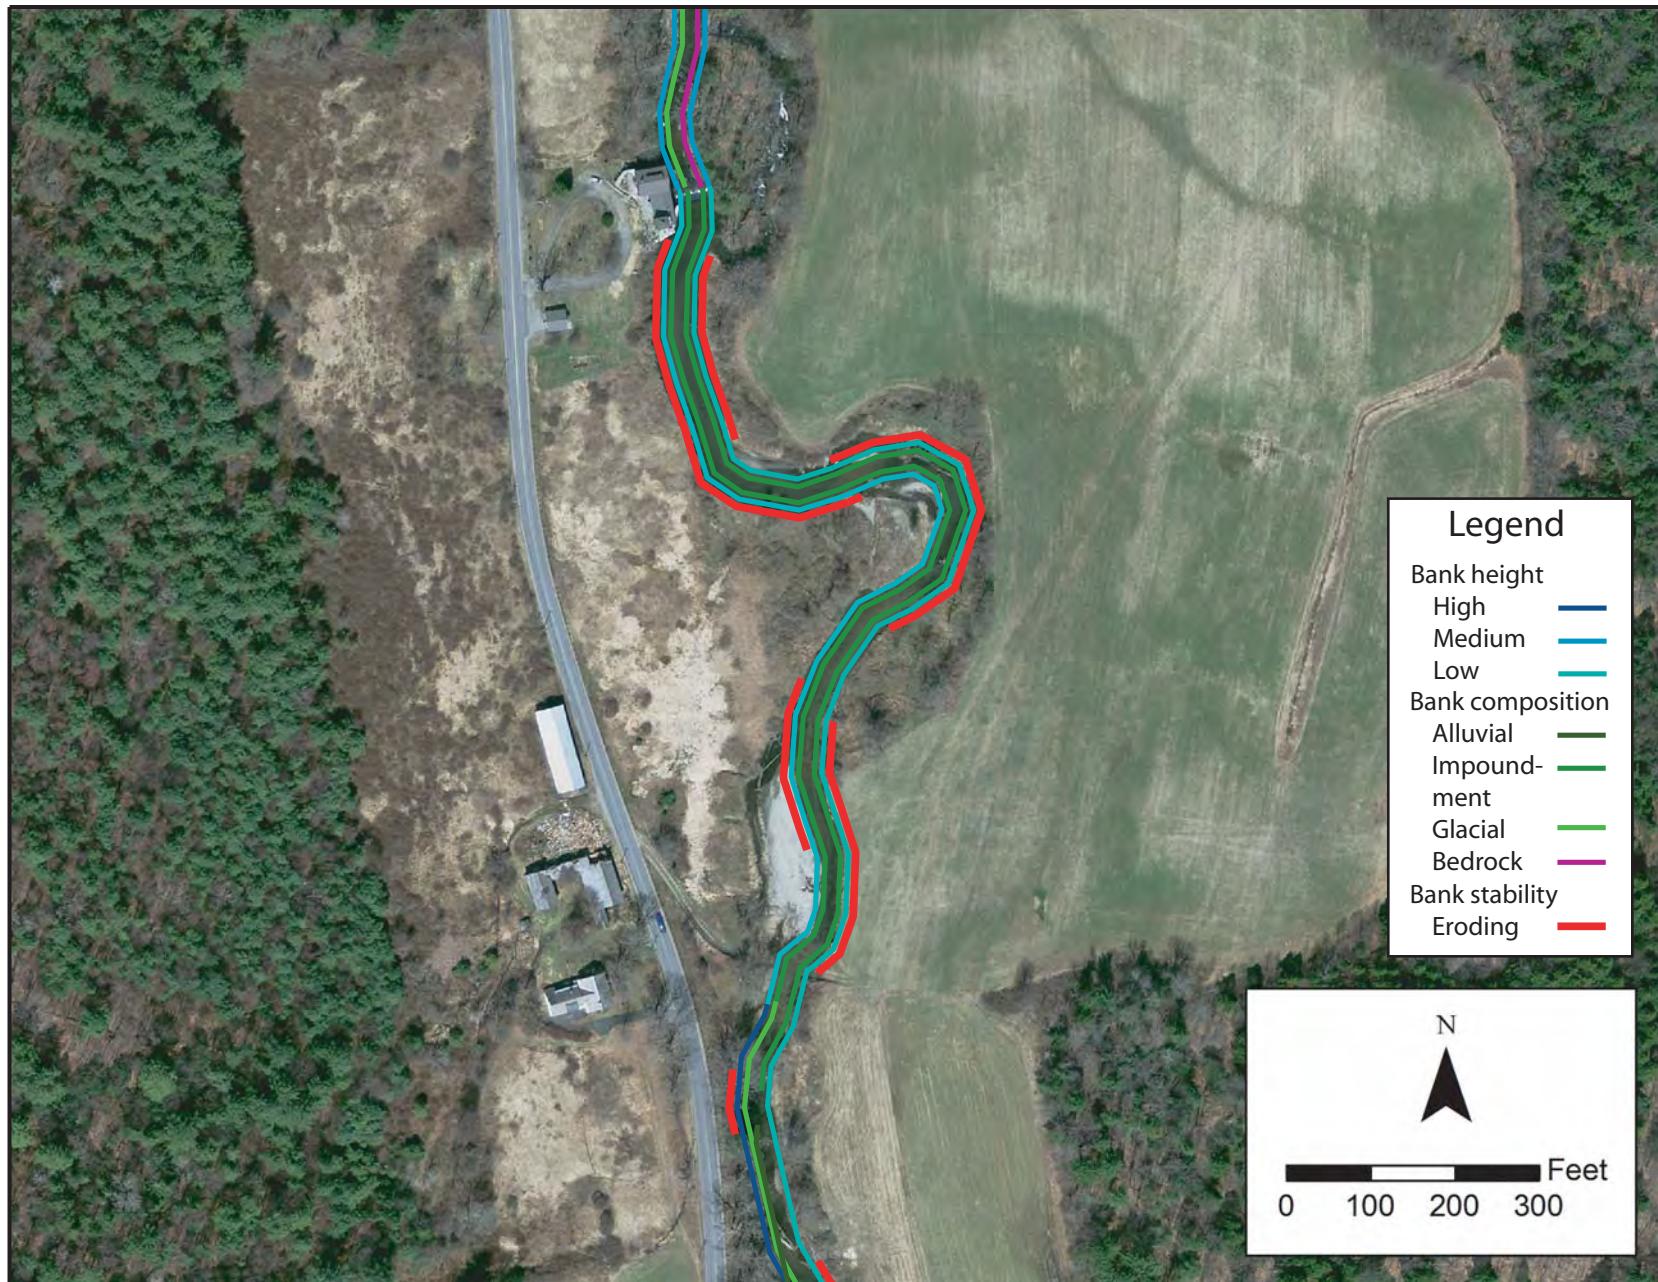
Figure 11. Comparison of bank composition (inner line), height (middle line), and stability (outer line) along a portion of South River.

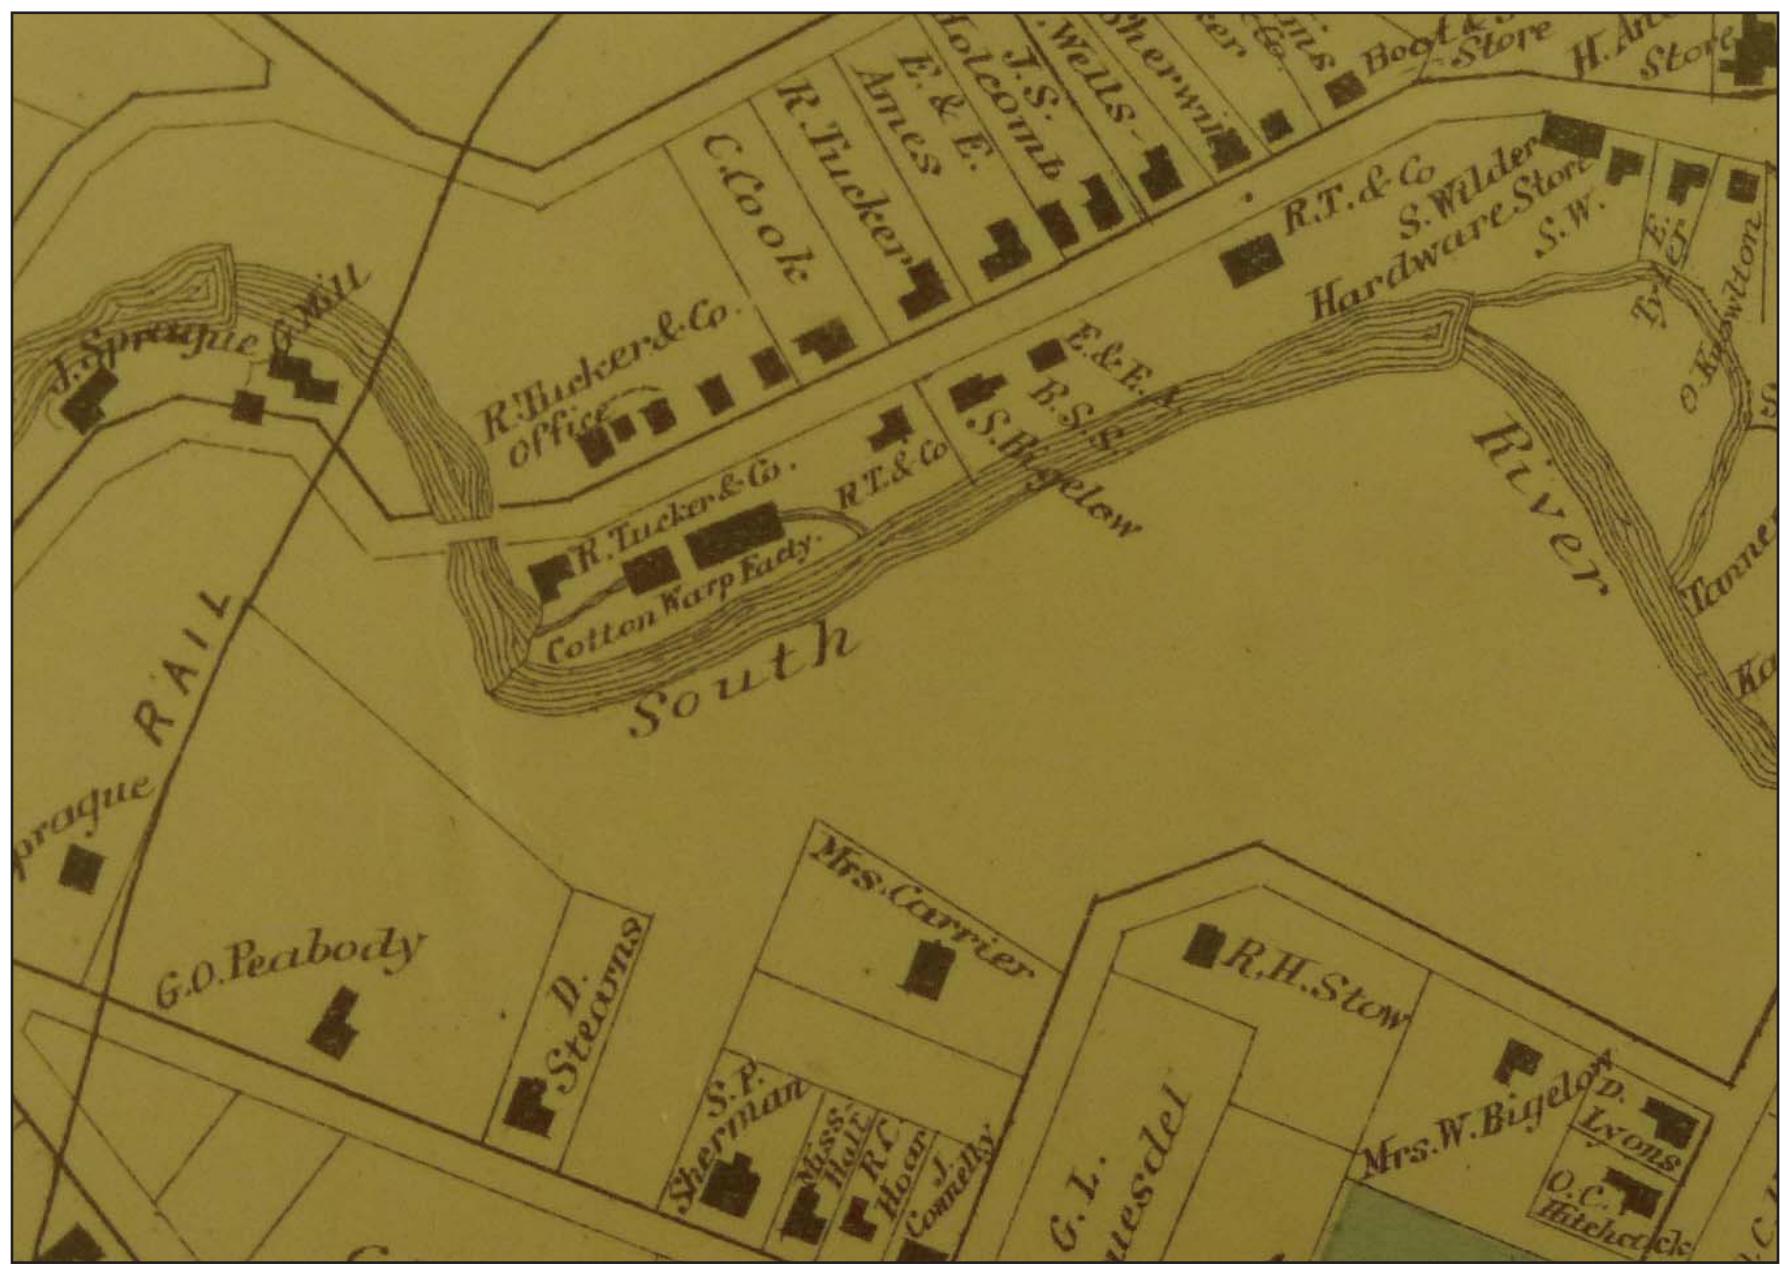
Figure 12. Historical map from 1871 (courtesy of Conway Historical Society) showing location of mill dams on a portion of South River along with other associated channel manipulations such as canals.
